School District of Brown Deer

Facility Study  
September 26, 2023

# Brown Deer Middle / High School

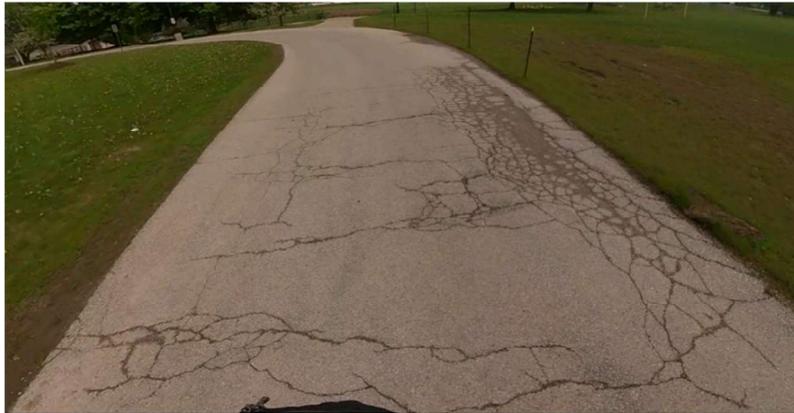
- Parking and drive lanes have several large cracks and should be considered for resurfacing - the back drive has some evidence of base failure and should have selective base repair prior to repaving.
- The gravel construction road is not being used for authorized purposes.

*Poor Asphalt*

- Replace selective sections of the drives.
- Remove Gravel construction road.

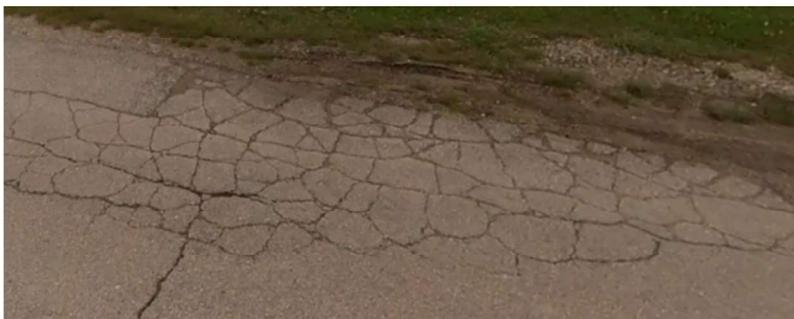
*"Alligator Cracking"*

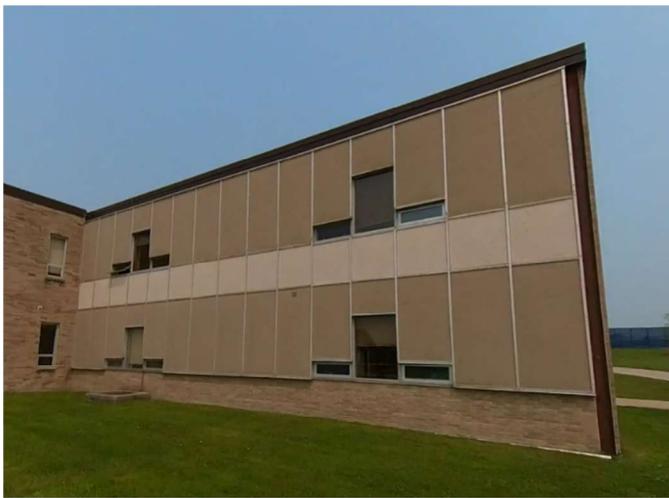
- Overall, the building envelope is in fair condition, generally varying with the age of the particular portion of the building.
- Several windows and curtain walls in the original wing of the building area, single pane with non-thermally broken frames.
- Roof Areas A, B, & D are in need of replacement.

*Exterior Curtain Wall*

- Consider replacing the windows and curtain walls in the oldest wing of the building with more energy-efficient windows.
- Perform a tuckpointing audit and repair as needed.
- Replace roofs A, B, & D.

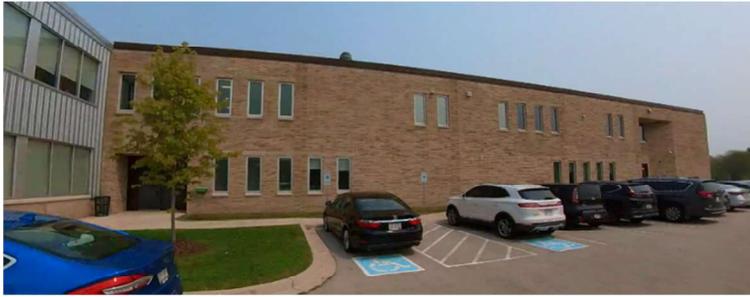
*Brick Exterior in good condition*

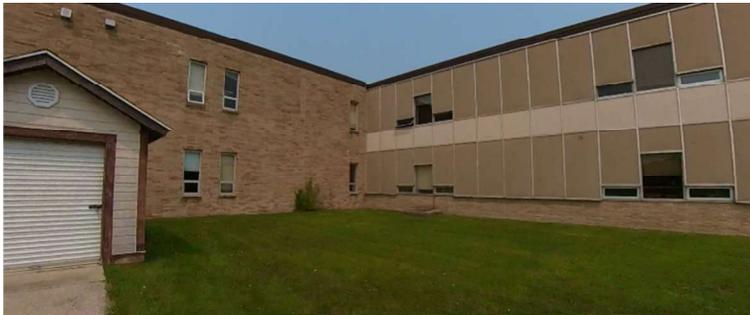
*Exterior Curtain Wall, fair to poor condition*

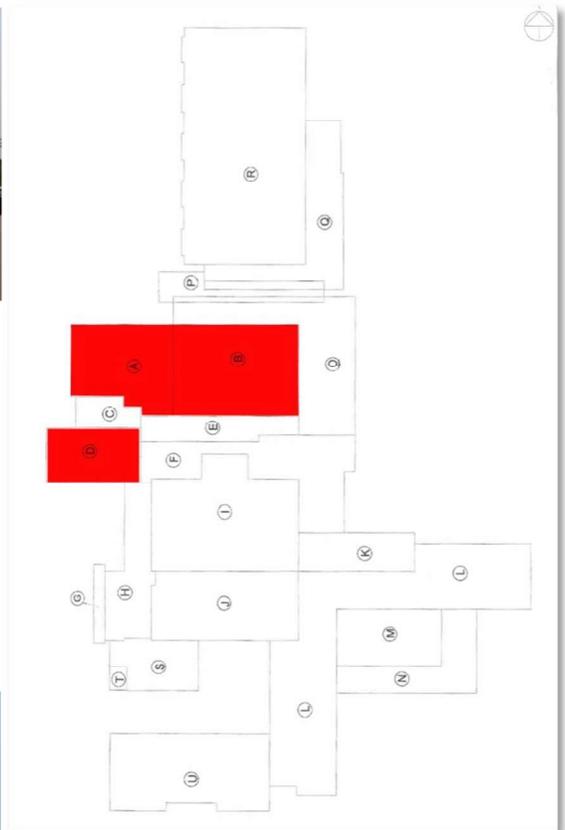
*High Priority Roofing Areas*

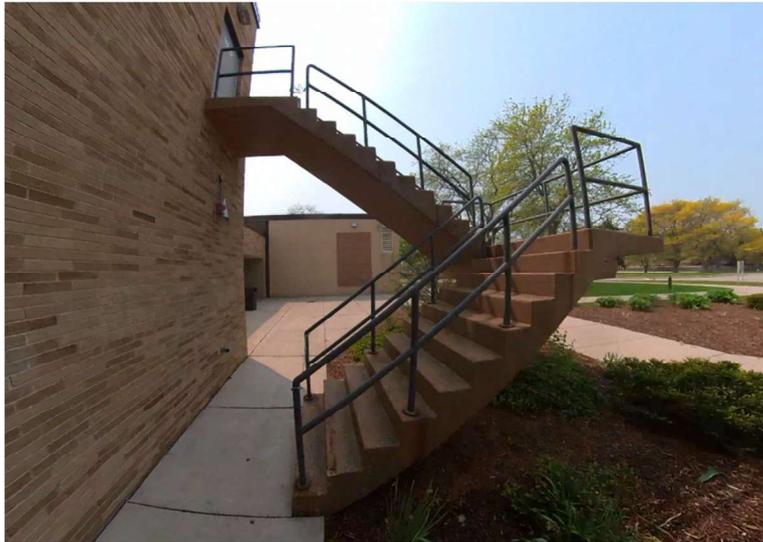
*Exterior Stair: signs of spalling, non-complaint guard rail*

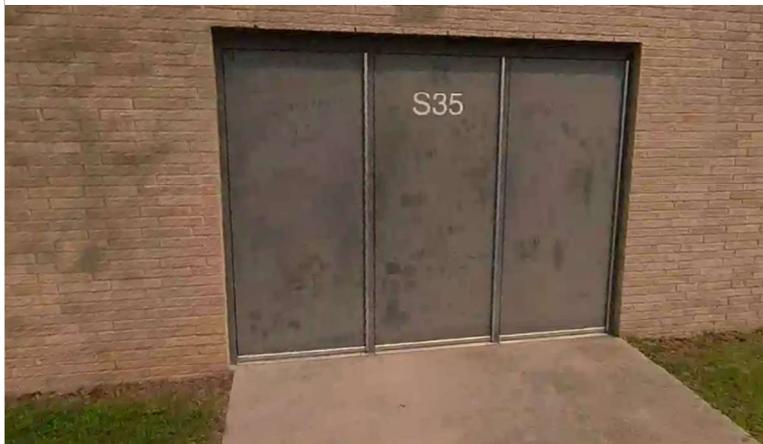
*Doors showing signs of oxidation - consider repainting*

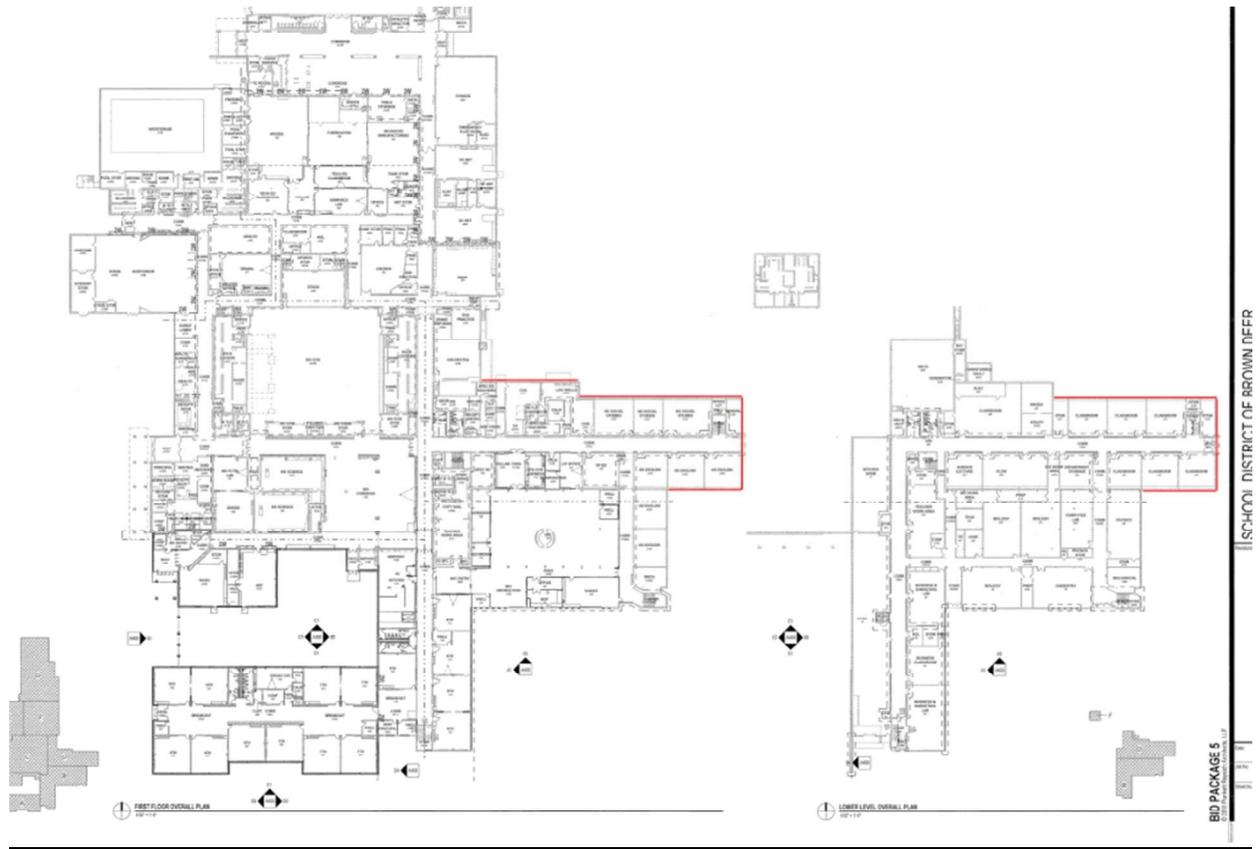
*Curtainwall Replacement*

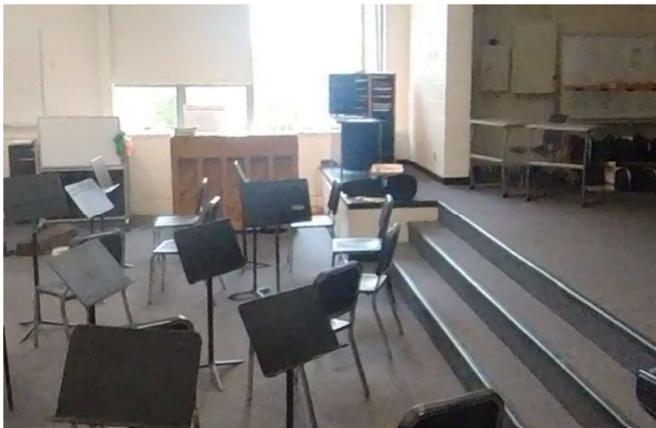
- The building is fully sprinkled.
- The platform in the orchestra room does not have a handrail.
- Select rooms have doorknobs.
- Most handrails are in good condition and compliant with current extension requirements.
- Select restrooms are not compliant with ADA (older restrooms & locker rooms).
- Pool does not have a lift.
- Pool spectator seating is not ADA-compliant.
- East Bleachers in MS Gym do not have ADA cutouts, stairs, guardrails, or handrails.
- The courtyard gate does not have an egress release or panic.

*No handrail*

- Consider rectifying minor compliance issues.
- Consider replacing bleachers.

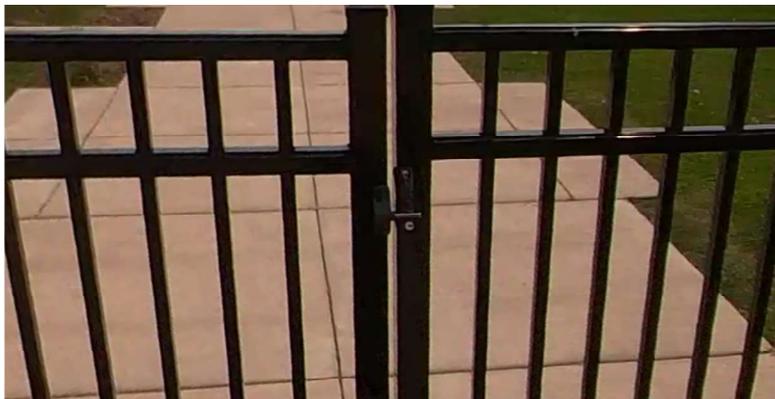
Gate latch could create an entrapment hazard

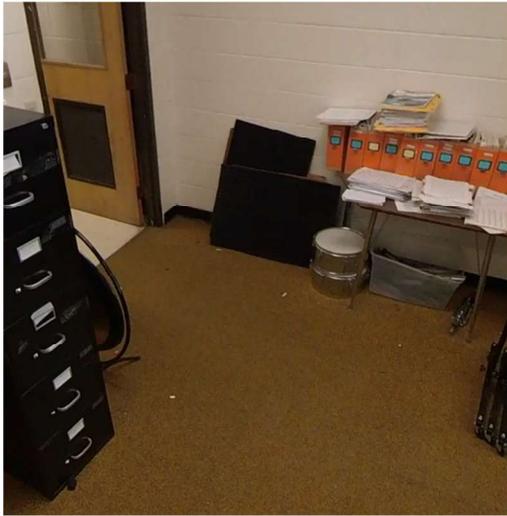
- Flooring in select rooms should be considered for replacement, including vinyl asbestos tile in many of the classrooms in the original building wings and the instrument storage and band uniform storage rooms.
- Ceilings in the different portions of the building vary in vintage and style. Consider replacing the old, dirty, and worn ceilings.
- Most doors in the original classroom wing have reached their end of life and should be considered for replacement.

*Old / worn carpet*

- Consider replacing flooring, ceiling, lights, and doors in select areas.

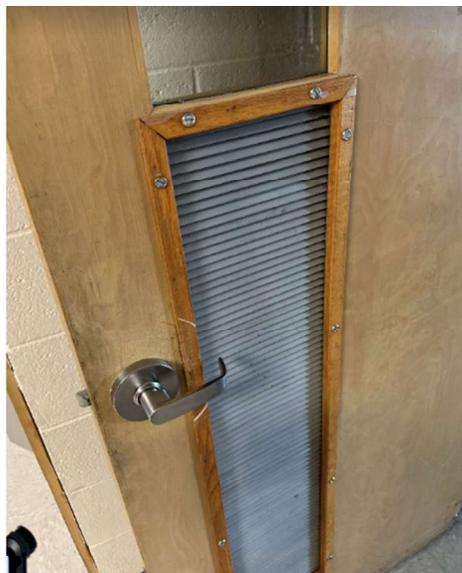
*Original doors - damaged, worn finishes*

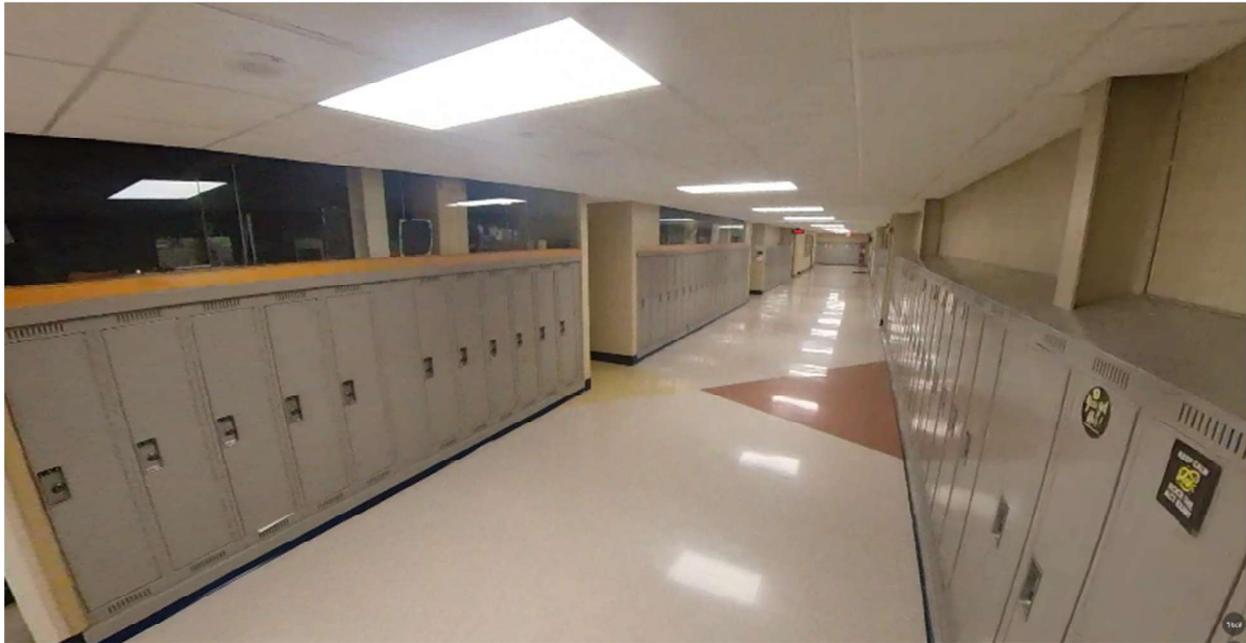
Example Corridor – Fair Condition

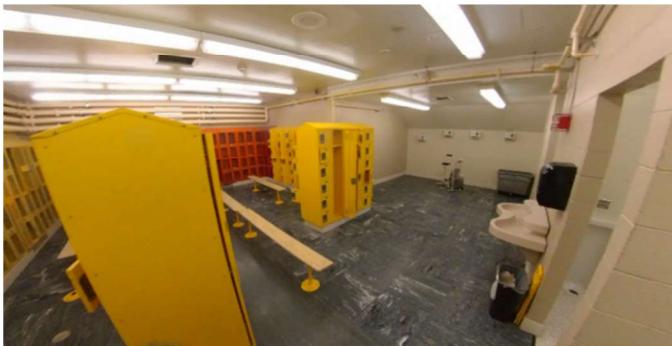
- The pool locker rooms are all an older vintage and are showing significant signs of wear.
- The older gymnasium is in fair condition. The bleachers appear of newer vintage and include stair aisles, handrails, and ADA cutouts.

*Pool Locker Rooms - Old Finishes, Damaged Lockers*

- Renovate high school pool locker rooms.
- Renovate middle school locker rooms.
- Evaluate the long-term natatorium needs and consider replacing the pool and spectator seating.
- Renovate basement locker rooms.
- Renovate existing space to accommodate wrestling or build a new wrestling room and associated lockers.

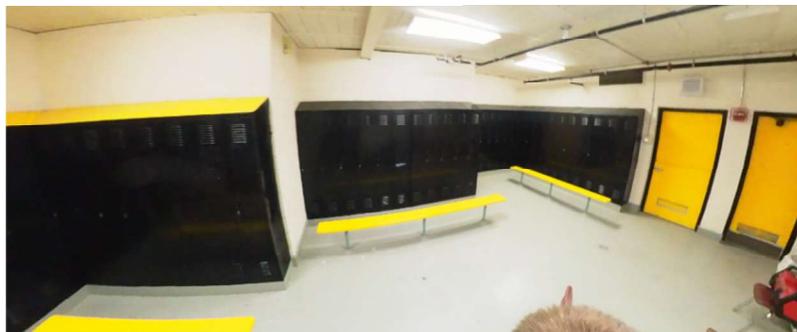
Basement Locker Rooms - Damaged Lockers, Outdated Finishes

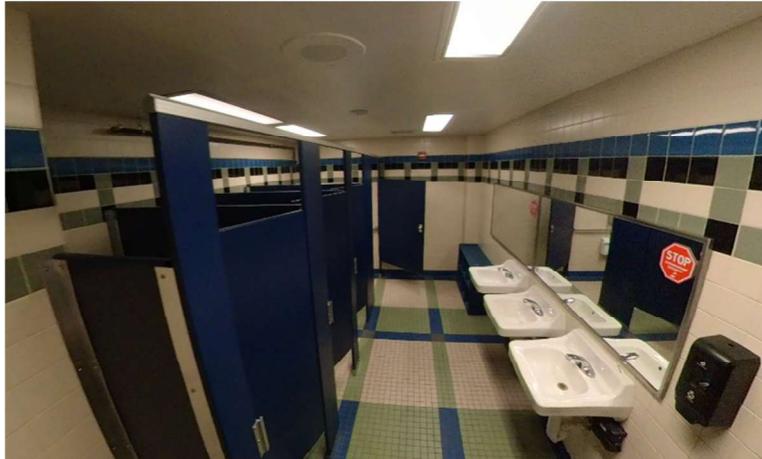
- Most of the MS/HS restrooms were updated in the 2018 referendum and are in good physical condition.
- There are a few public and staff restrooms that should be updated to meet ADA and contemporary finishes.

*Older Restroom Finishes*

- Renovate select restrooms.

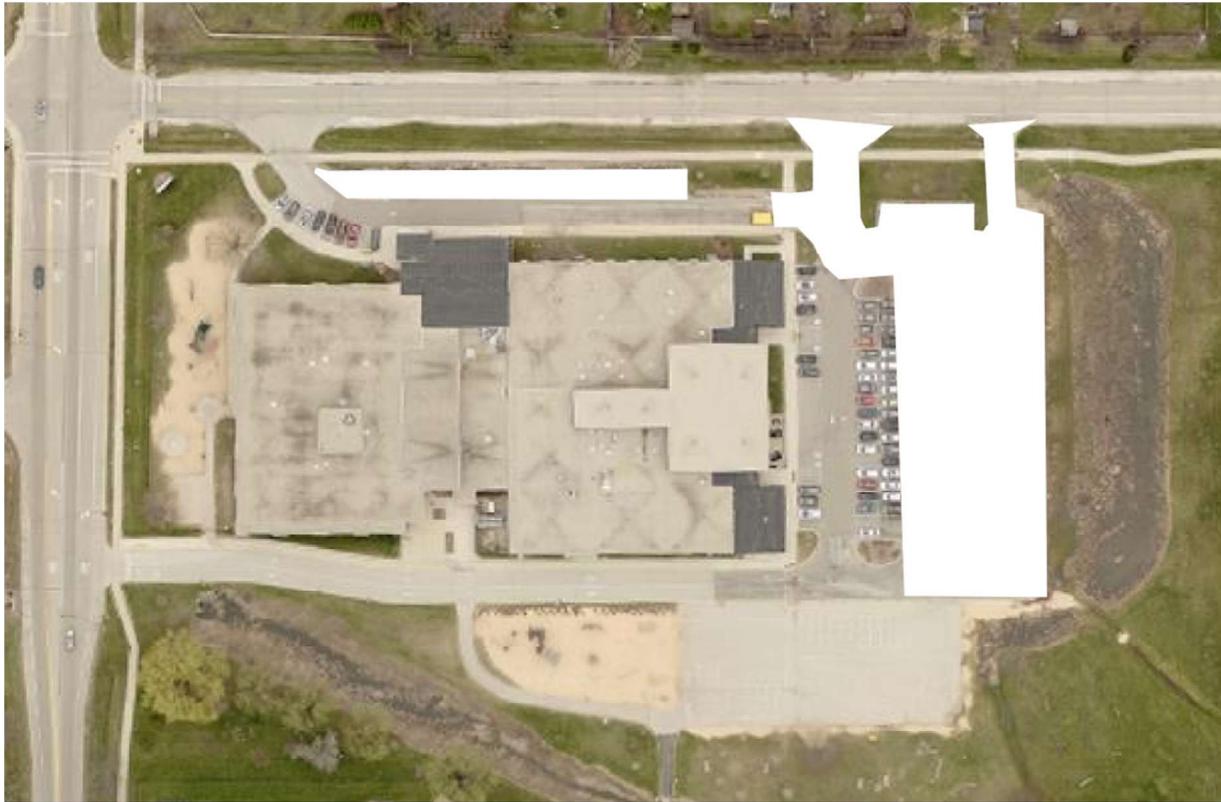
*Older Asphalt - Recommend Replacing*

- Consider removing and reconditioning the remaining portions of the asphalt drives.
- Replace the wood mulch surface with a rubberized play surface.

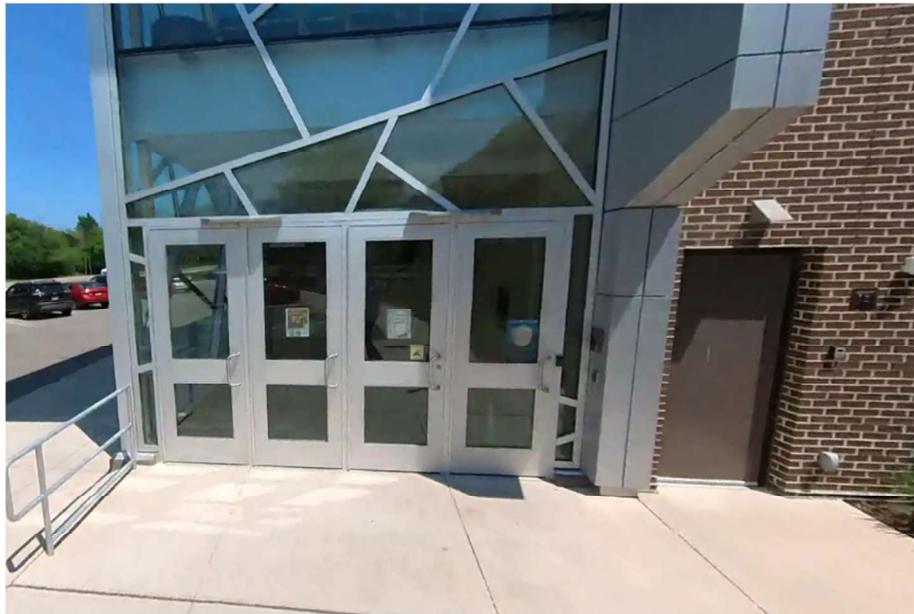
*Secure Entrance - No Door Identification*

- Install new numbers on all exterior doors.
- Install classroom identification on one window per classroom.
- Install directory signage at special doors (Main Entrance, Receiving, Maintenance, Electrical Room, etc.).

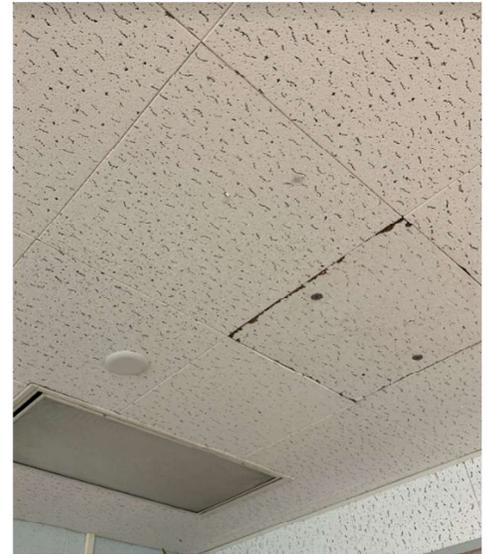
1 Older & Worn Ceilings

- Consider replacing the older ceilings and flooring throughout the building.

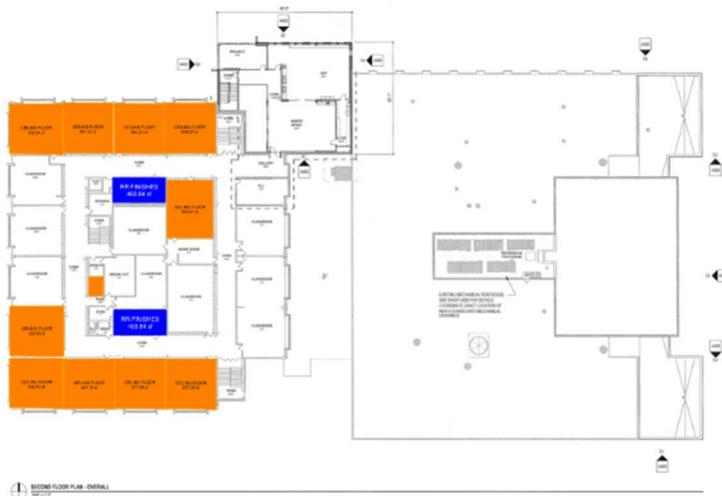
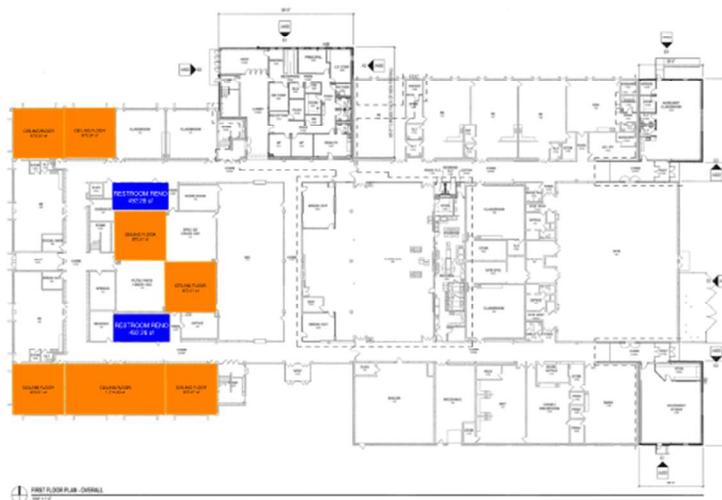
Rooms w/ Outdated Finishes

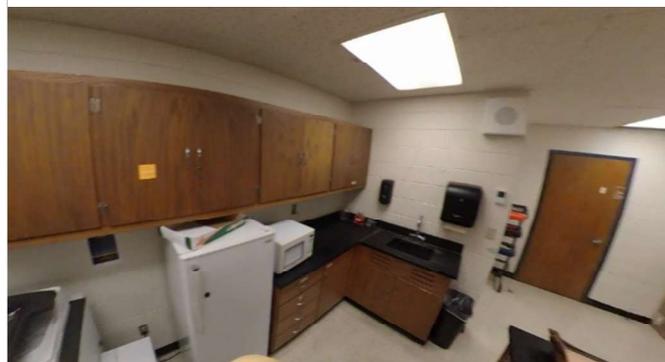
*Teacher Work Room – Original Science Prep Cabinets*

- Consider replacing the original science prep room casework with new and updating the finishes in the room.

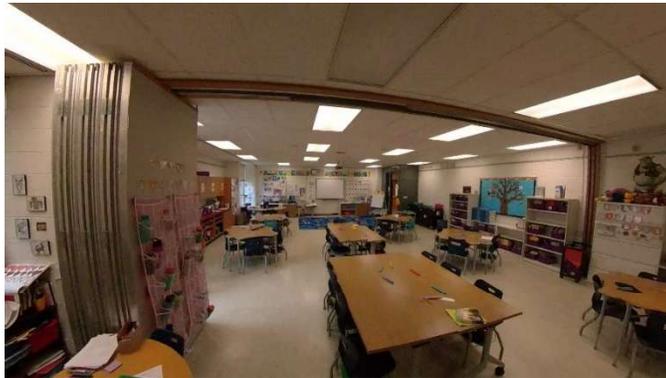
*Old Heavy folding partition*

- Consider replacing the folding partitions with an easier-to-use solution.
- Consider updating finishes older than 2012.
- Consider replacing projector-based displays with screen-based interactive whiteboards.

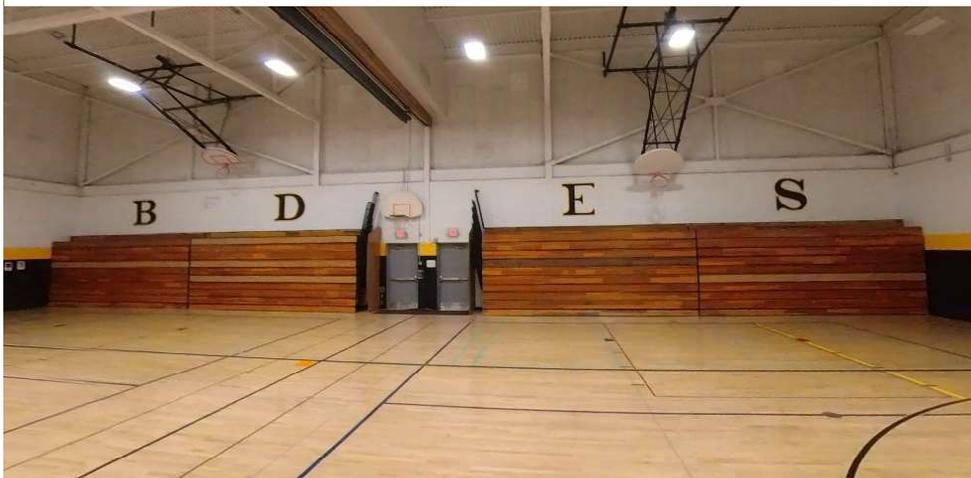
*Older Bleachers - No Stair or ADA Complaint Sections*

- Consider replacing bleachers to provide ADA-compliant seating.

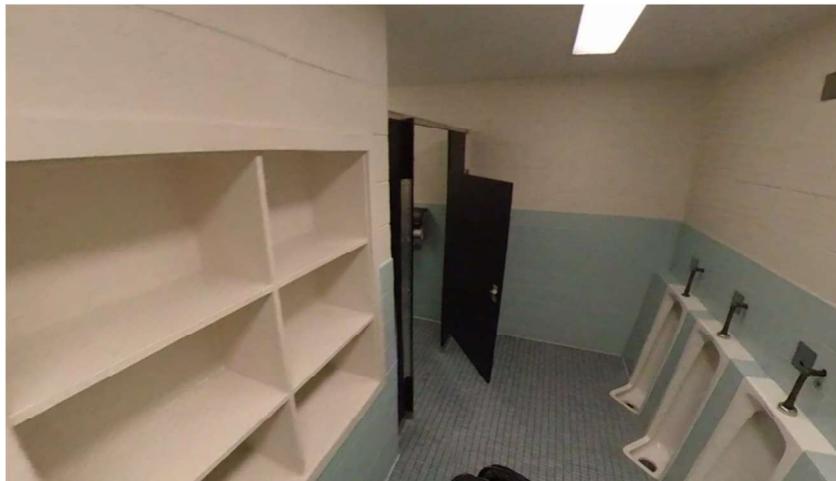
*Original Restrooms - Older Finishes*

- Update the (4) restrooms in the original classroom wing.

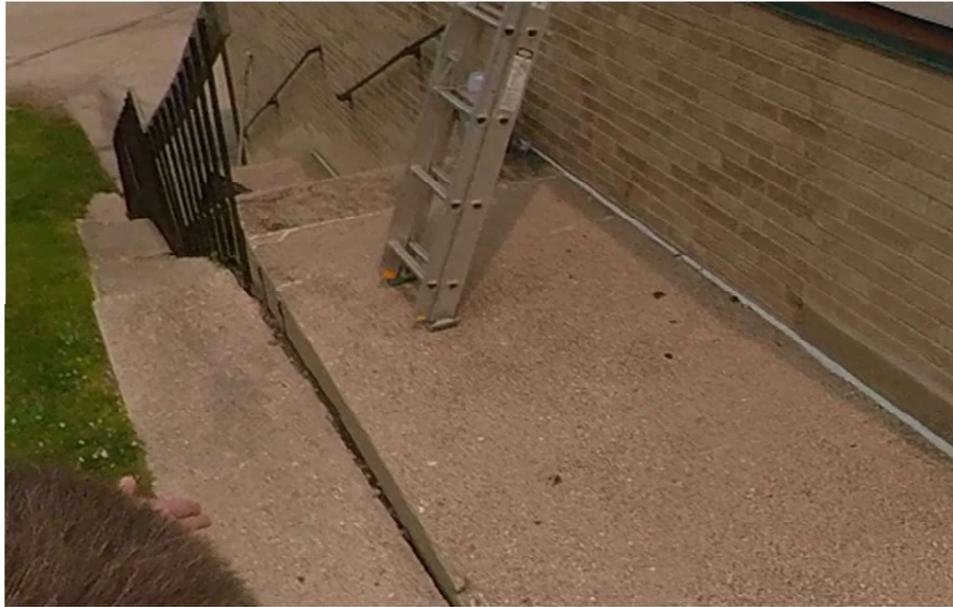
*Exterior Stair - Erosion and Settling Issues*

- Consider removing and replacing stairs, along with proper grading and stair edge construction.
- Consider regrading and repaving the asphalt drive and apron.

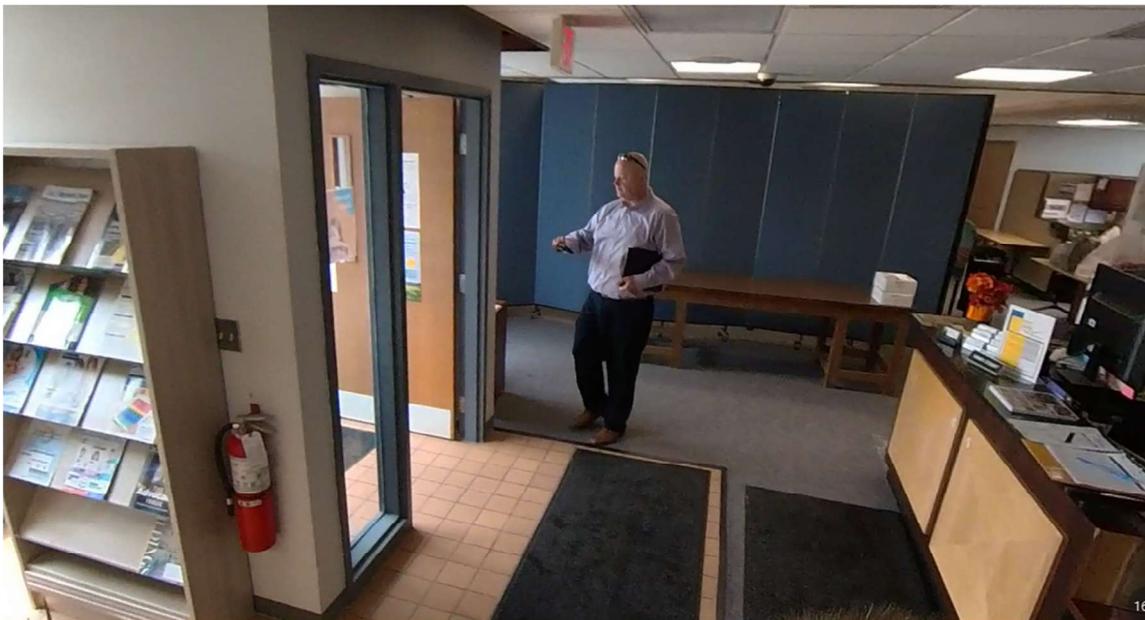
*Entry Sequence Allows Free Access Before Reception Can Vet Visitors*

- Renovate the front entrance area to allow for a transaction window and waiting area.
- Consider adding fire safety features such as sprinklers and fire alarms in future renovations.
- Consider the longevity of the facility and the upgrades required vs. replacements that can better facilitate current and desired programmatic needs.

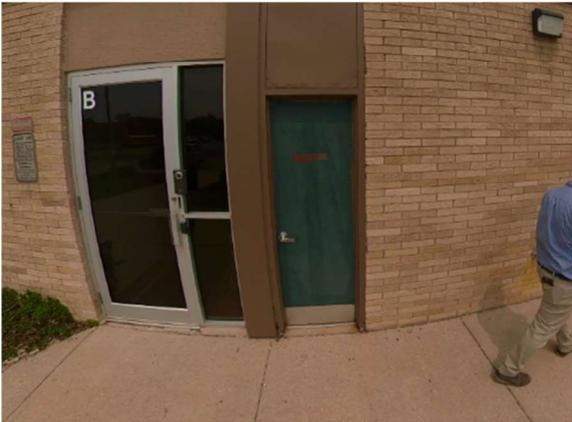
*Exterior Restroom Door - Poor Condition*

- Consider replacing the exterior stair in conjunction with the wall repair below.
- Consider replacing the window system with new thermally broken windows.
- Consider renovating the restrooms and removing the exterior access.

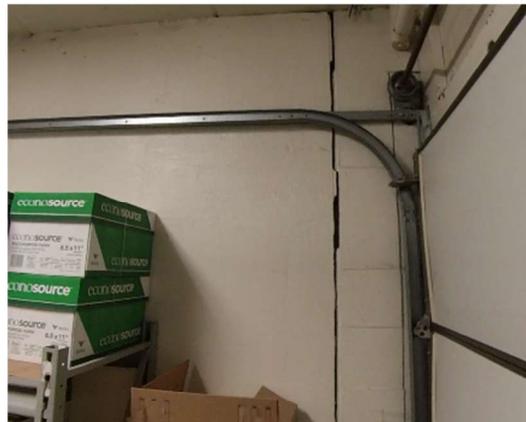
*Basement Wall - Separation at Corner*

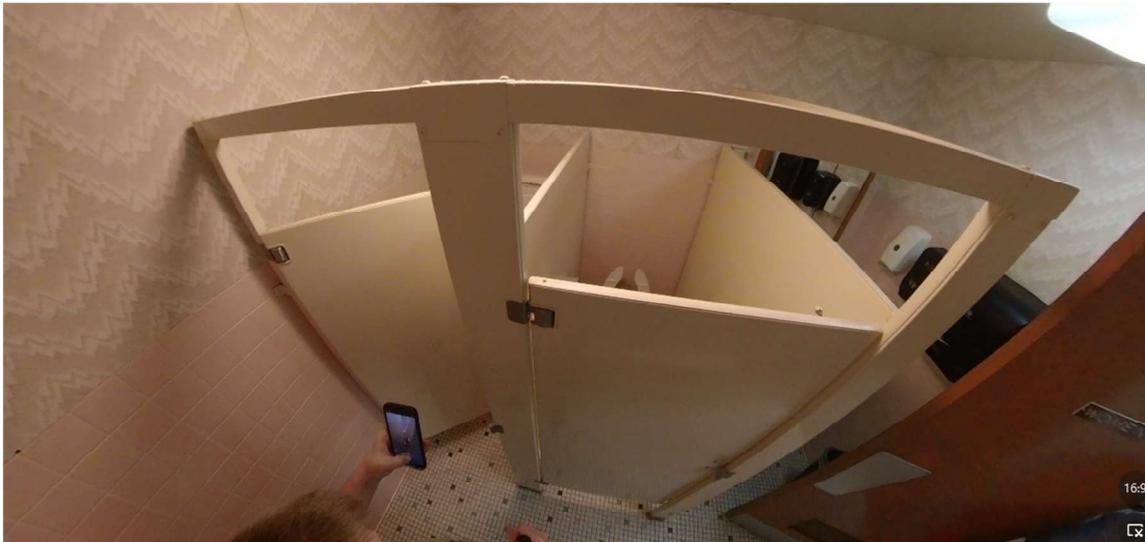
*No ADA Complaint Restrooms*

- Consider reconfiguring unused exterior restrooms back into the main restrooms suite and revise to create ADA-compliant restrooms

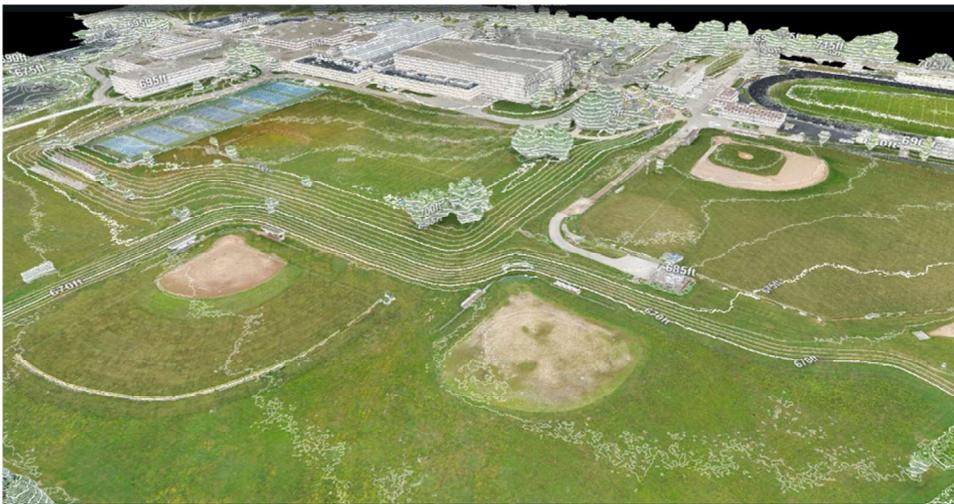
*Aerial Image Showing Notable Elevation Changes*

- Consider adding an electronic scoreboard for softball.
- Consider regrading the playing surfaces to eliminate inconsistencies and drainage issues.
- Consider creating ADA-compliant paths and seating pads to allow access to all sports facilities.

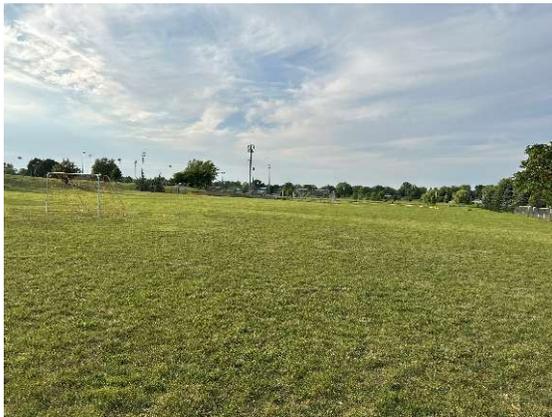
*Jr Soccer Field Has Notable Cross-Slope*

- Consider installing lighting at the Varsity soccer field.
- Update the parking lighting for safety and security purposes.
- Consider creating ADA-compliant paths and seating pads to allow access to all sports facilities.
- Consider building up additional play space around the varsity soccer field.
- Consider replacing the nets behind the goals and adding fencing where needed to keep soccer balls close to the field of play when kicked out of bounds.

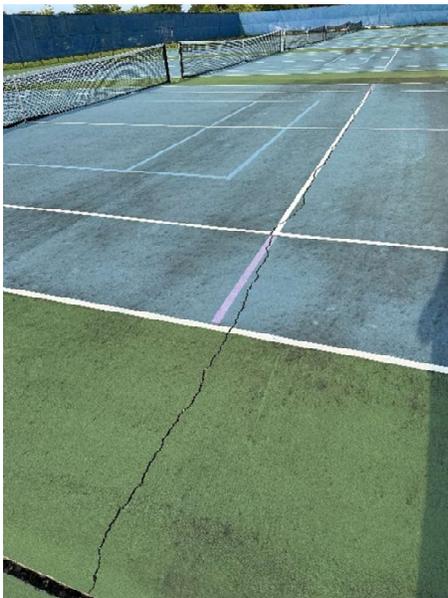
*Cracking in Tennis Court Surface*

- Consider replacing the tennis courts.
- Consider adding an 8<sup>th</sup> tennis court to replace one that was removed during the 2018 referendum.
- Consider building a concrete pad and path to the tennis court seating.

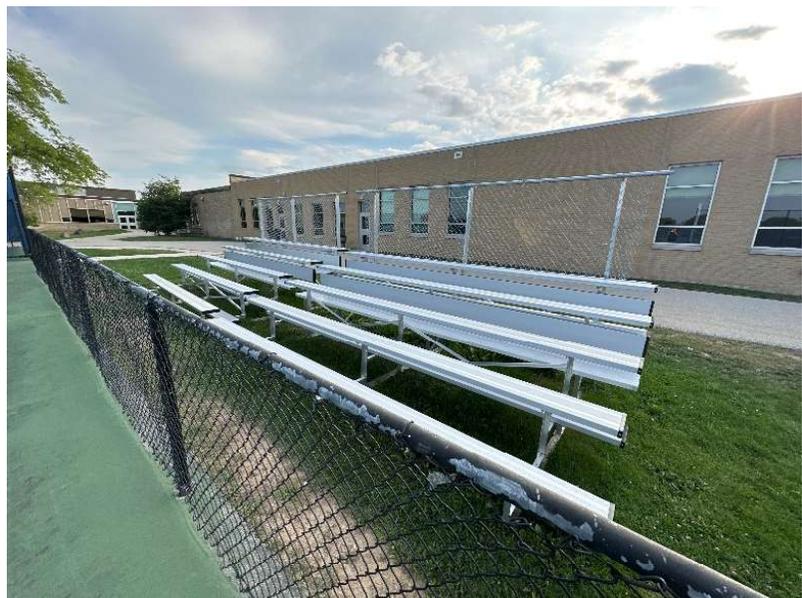
*Tennis Seating - Not ADA Compliant*
