School District of Brown Deer

Facility Study  
September 26, 2023

# Brown Deer Middle / High School

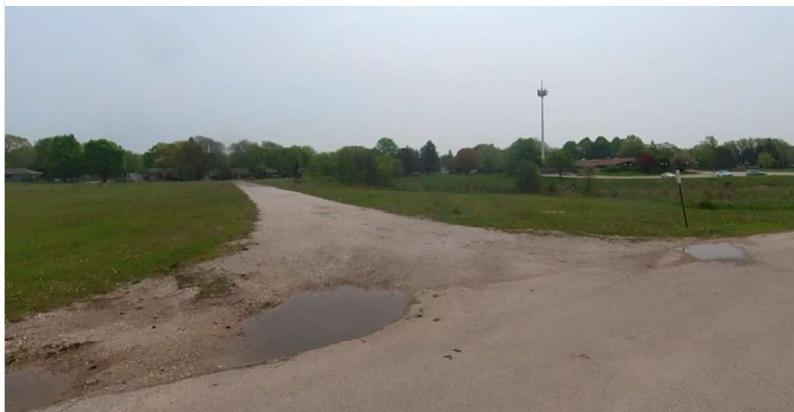
- Parking and drive lanes have several large cracks and should be considered for resurfacing - the back drive has some evidence of base failure and should have selective base repair prior to repaving.
- The gravel construction road is not being used for authorized purposes.

*Poor Asphalt and Ponding*

- Replace selective sections of the drives.
- Remove Gravel construction road.

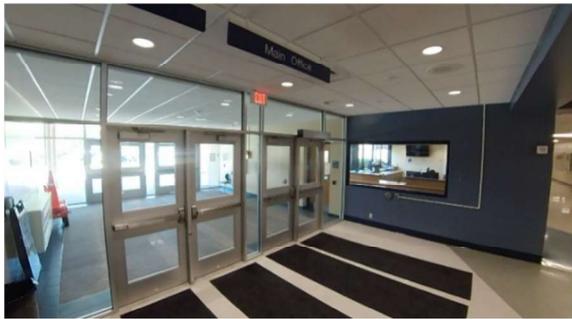
*Existing HS Secure Entrance*

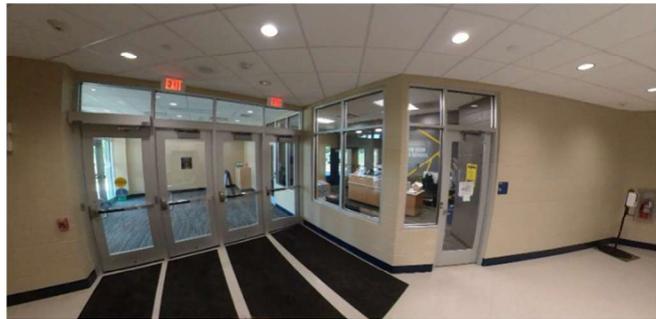
*Existing MS Secure Entrance*

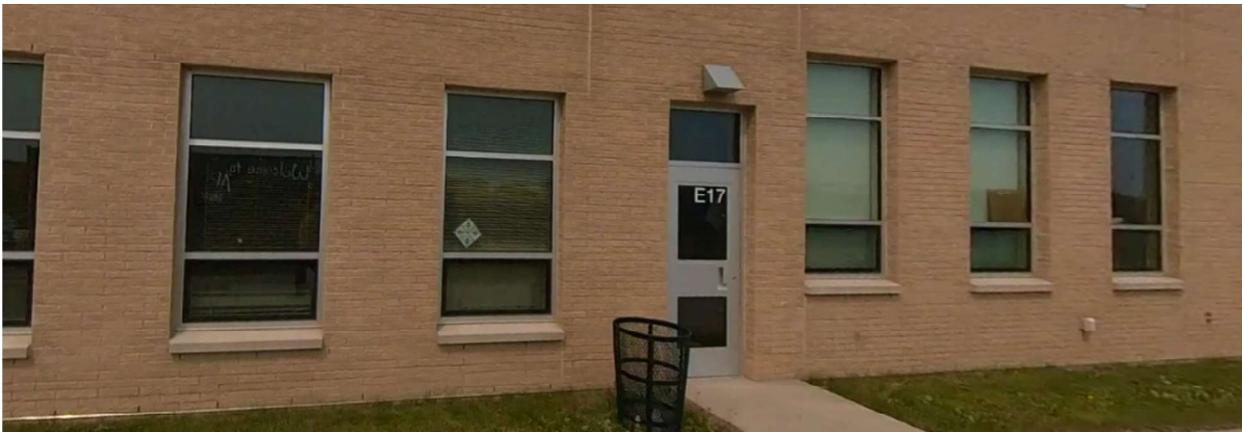
*Existing Door Labels - Classrooms not labeled*

- Ensure all doors are properly numbered and specialty doors identified.
- Install ballistic window film on interior windows in the Middle School

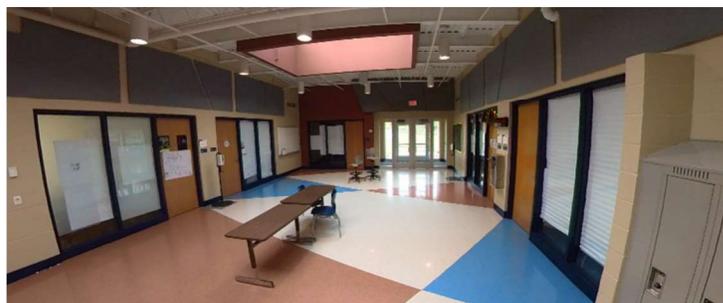
*MS interior glazing*

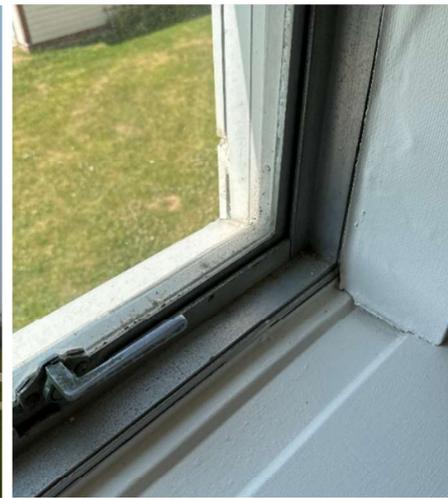
- Overall, the building envelope is in fair condition, generally varying with the age of the particular portion of the building.
- Several windows and curtain walls in the original wing of the building area, single pane with non-thermally broken frames.
- Roof Areas A, B, & D are in need of replacement.

*Single glazed window*

- Consider replacing the windows and curtain walls in the oldest wing of the building with more energy-efficient windows.
- Perform a tuckpointing audit and repair as needed.
- Replace roofs A, B, & D.

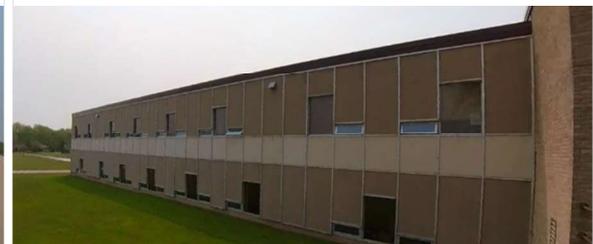
*Exterior Curtain Wall - Poor Condition*

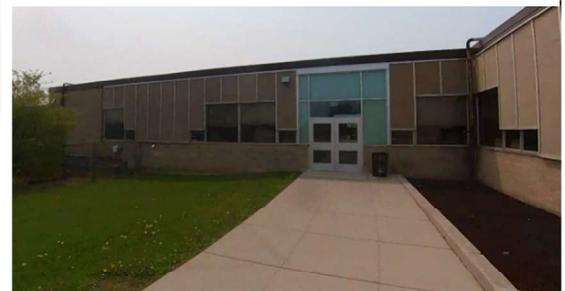
*Exterior Curtain Wall - Fair to Poor Condition*

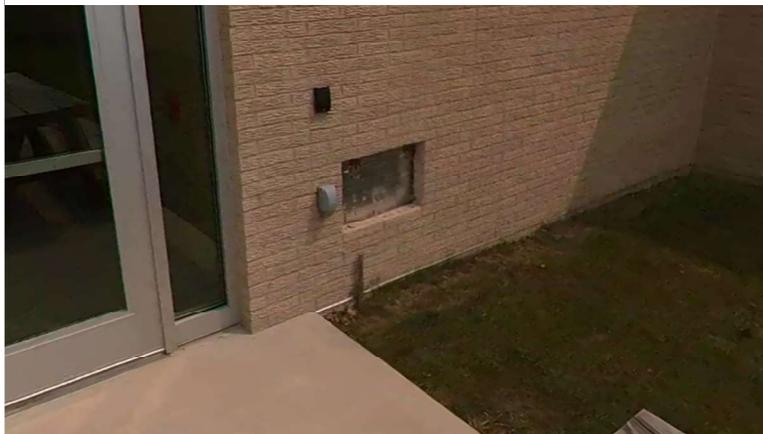
*Infill Brick or provide louver/cover*

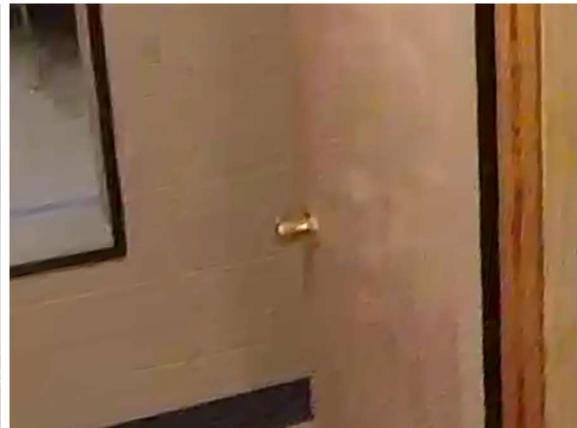
*Provide lever handles for ADA compliance*

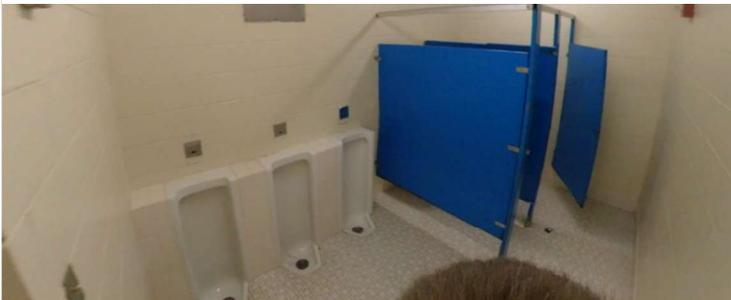
*Non-compliant toilet stalls*

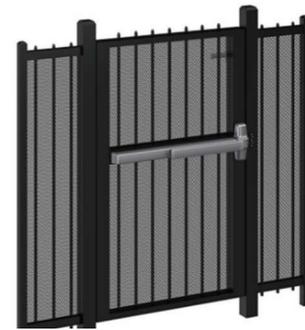
Latching Gate w/ panic solution

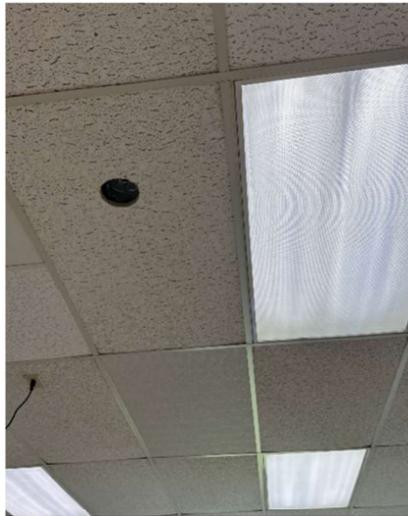
- Flooring in select rooms should be considered for replacement, including vinyl asbestos tile in many of the classrooms in the original building wings and the instrument storage and band uniform storage rooms.
- Ceilings in the different portions of the building vary in vintage and style. Consider replacing the old, dirty, and worn ceilings.
- Most doors in the original classroom wing have reached their end of life and should be considered for replacement.

*Old / dirty ceilings*

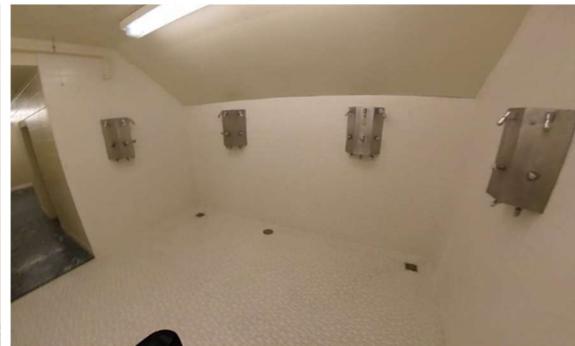
*Communal Showers - less likely to be used by students*

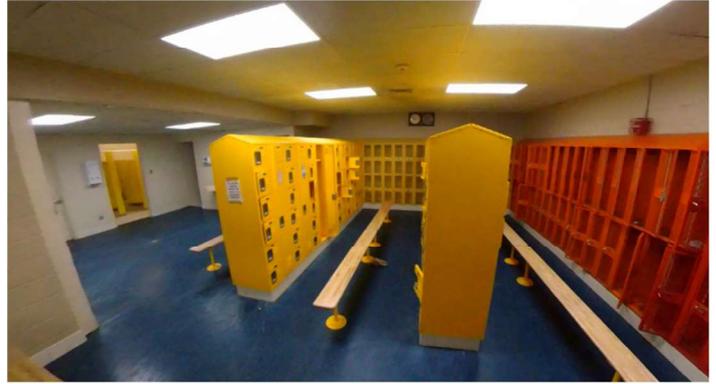
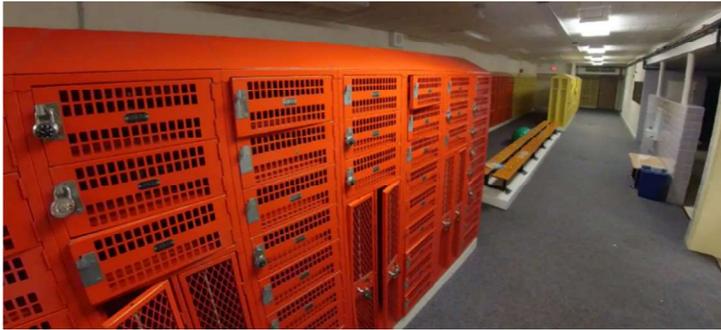
- The pool locker rooms are all an older vintage and are showing significant signs of wear.
- The older gymnasium is in fair condition. The bleachers appear of newer vintage and include stair aisles, handrails, and ADA cutouts.

Pool Locker Room

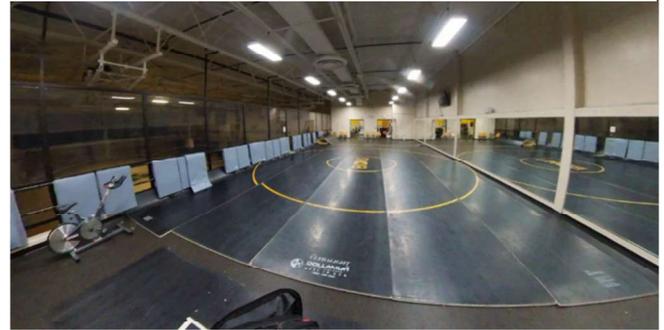
Wrestling Room – Space is limited

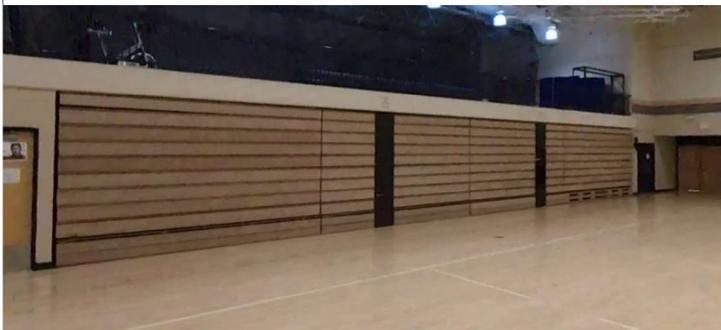
Bleachers - no handrails or stair sections

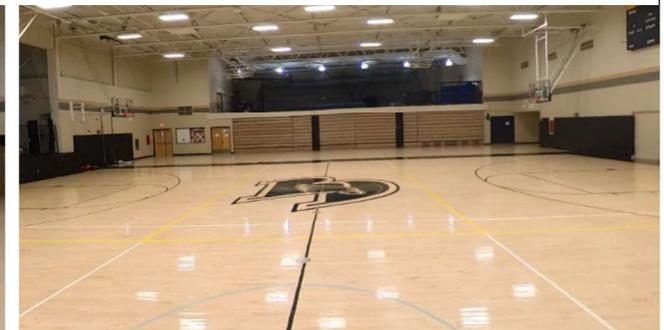
Gym Floor - Good Condition

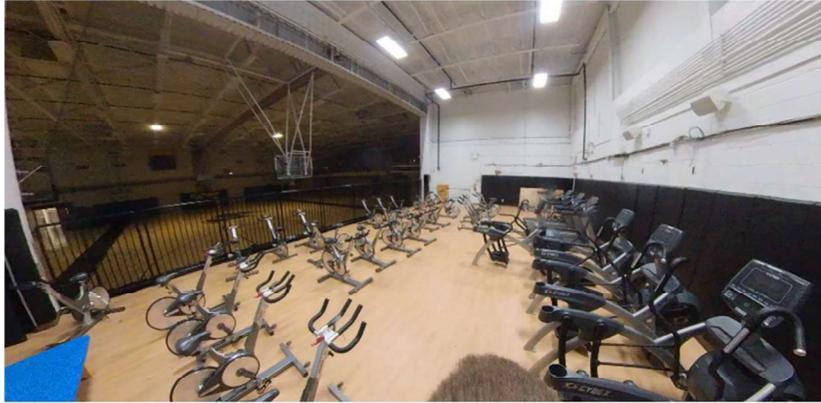
Cardio Fitness

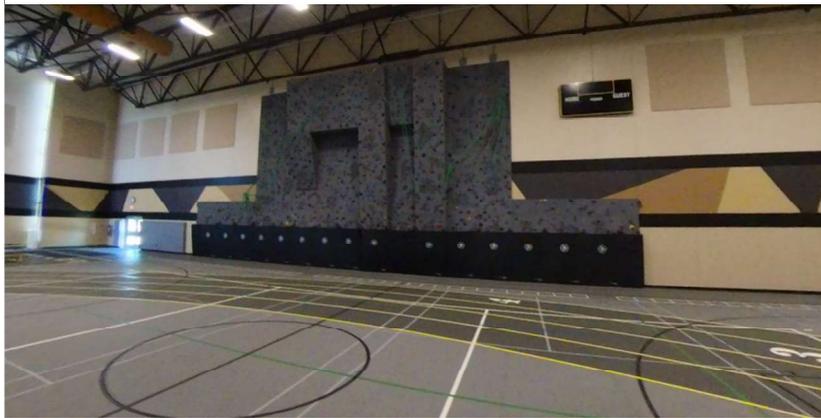
Field House - Good Condition

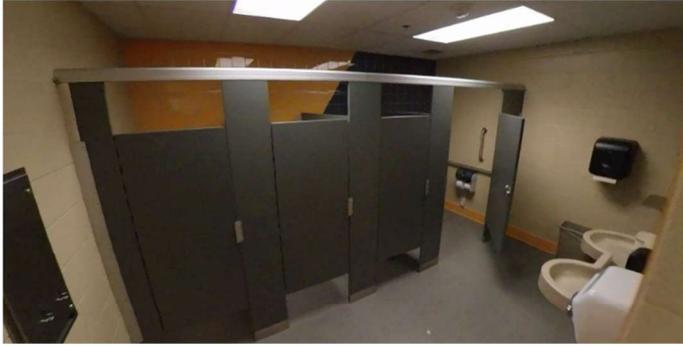
Fieldhouse Locker Restrooms - Good Condition

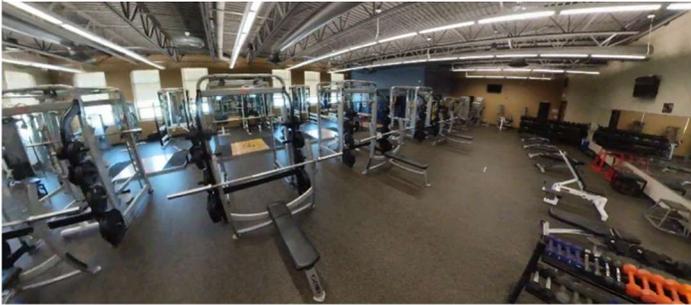
Fitness Center - Good Condition

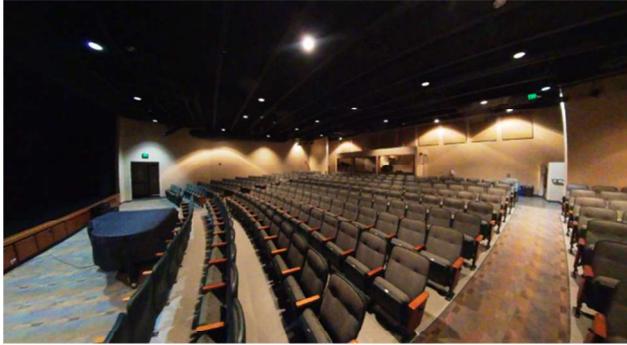
Auditorium

- The auditorium is in good condition; however, the district would like to look into replacing or reupholstering the seating.
- The auditorium appears to seat about 300 and is good for smaller performances. It does not have a full-fly loft or an orchestra pit, and may be challenging to house larger ensembles.
- The Band room.

- Consider replacing the auditorium seating.

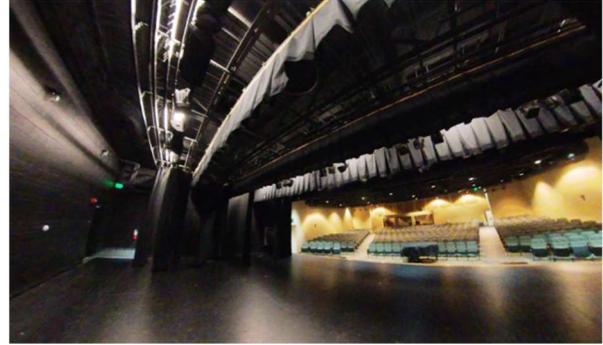
Stage - no fly loft limits production capability

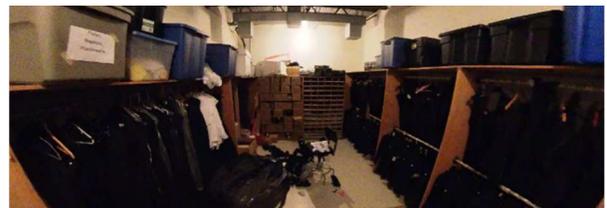
Music Storage - low lighting, outdated flooring, not ADA compliant

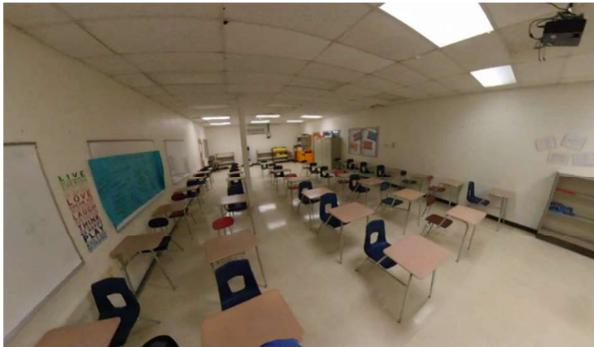
- The General HS Classrooms vary in age since their last renovation.
- Most classrooms in the original building wing still have their original finishes.
- Furniture in many of these classrooms is also older and less flexible for today's collaborative learning environments.
- Classroom presentation technology is mostly projector-based, which can be restricted by light levels in the room as well as shadows caused by the operator.

*HS Classroom - Outdated Finishes*

- Remove and replace old flooring, paint walls, and replace ceilings/lighting in select rooms.
- Consider replacing the older student furniture.
- Consider replacing projector-based presentation systems with interactive screens.

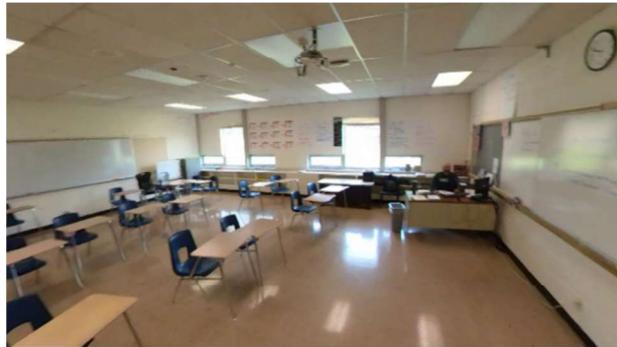
*HS Classroom - Outdated Finishes*

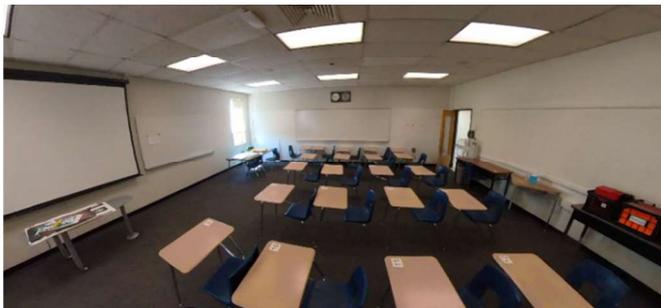
*HS Classroom - Older Finishes*

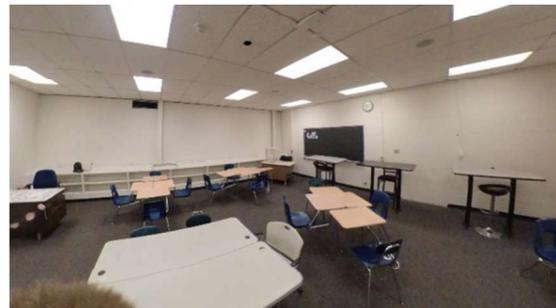
*HS Classroom - Older Finishes*

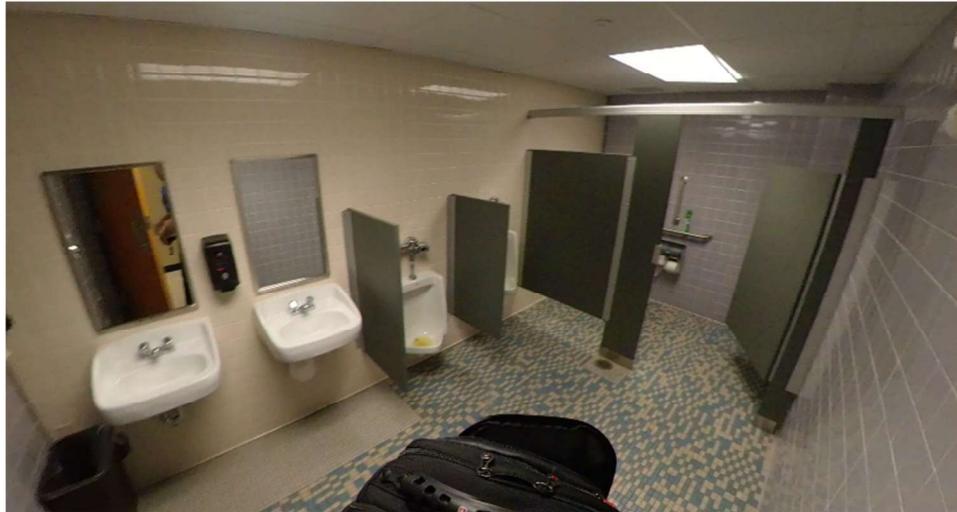
- Most of the MS/HS restrooms were updated in the 2018 referendum and are in good physical condition.
- There are a few public and staff restrooms that should be updated to meet ADA and contemporary finishes.

*Older Restroom Finishes*

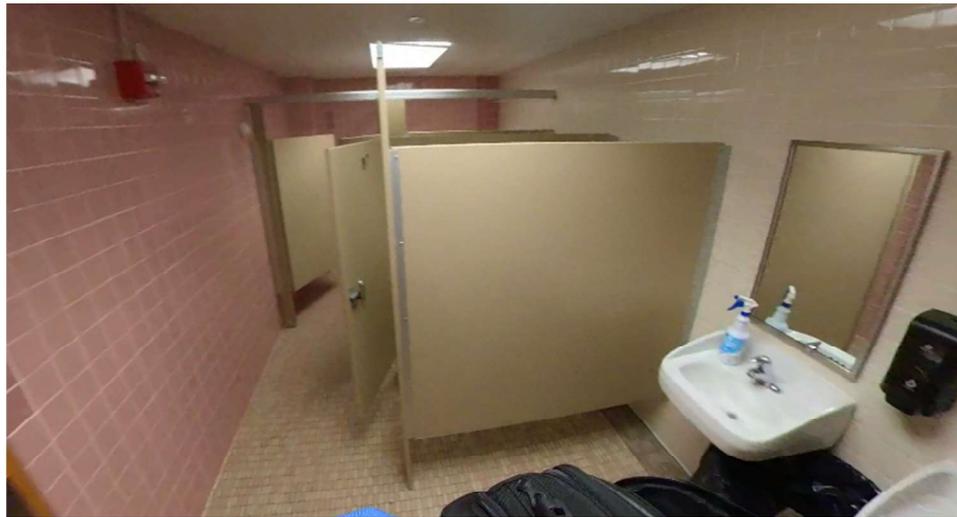
*Older Restroom Finishes*

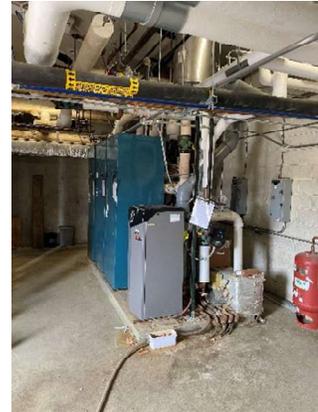
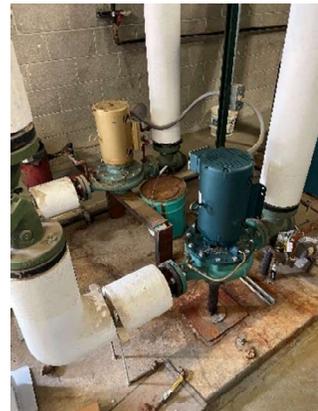
- Installed in 2003 / 20 years old
    - Average service life is 30 years
  - Boiler circulation pumps provided as part of each boiler
    - Pumps are in below-average condition

- Pumps are constant volume
  - Main heating water pumps are variable-speed pumps
    - (2) inline pumps manufactured by Taco
    - Pumps are in average condition and are served by Variable Frequency Drives

- Boiler circulation pumps provided as part of each boiler
    - Pumps are in below-average condition
    - Pumps are constant volume
  - Main heating water pumps are variable-speed pumps

- (2) base-mounted pumps manufactured by Bell & Gossett
    - Pumps are in average condition and are served by Variable Frequency Drives

- ✓ Begin planning for replacement of the boiler plants in the next 5-10 years, beginning with the HS boiler plant.

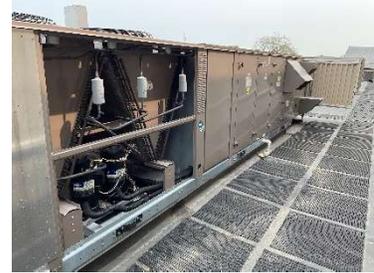
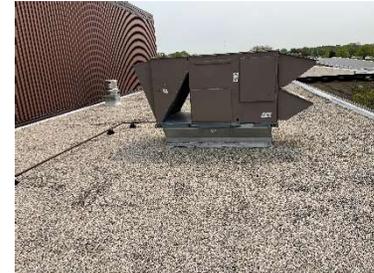
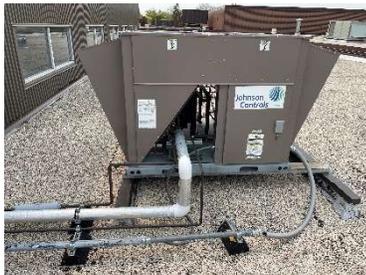
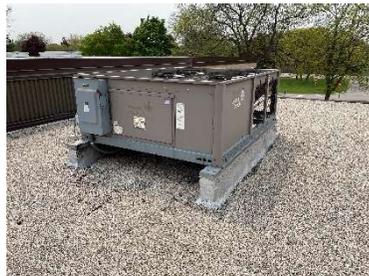
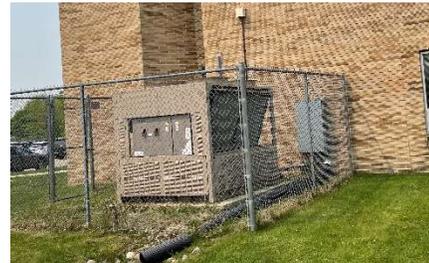
- In good condition
    - Average service life of rooftop units is 15 years
  - (12) Air Cooled Condensing Units serve Air Handling Units
    - Manufactured by York and Carrier

- (2) R22 units installed in 2008 / 15 years old
    - (5) R410A units installed in 2012 / 11 years old
    - (5) R410A units installed in 2019 / 4 years old

- In good condition
    - Average service life of condensing units is 20 years
  - Multiple Ductless Split Systems provide cooling for spaces
    - Manufactured by Mitsubishi and Sanyo

- ✓ Begin planning for replacement of the R22 condensing units in the next 1-5 years, or at the same time the corresponding air handling units are replaced.
- ✓ Begin planning for replacement of the 2012 rooftop units in the next 5-10 years.
- ✓ Begin planning for replacement of the 2013 condensing units in the next 5-10 years.

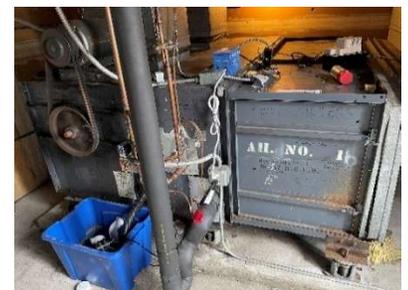
- ✓ West IMC & Classrooms are served by Indoor Air Handling Unit-1
  - Original to building
  - Average service life is 30 years
  - In poor condition
  - Provides Heating (hot water), Cooling (split dx), and Ventilation

- Zoning provided by constant volume terminal reheat
  - Hot water coils provide reheat
  - Original to building old
  - Average service life is 20 years
  - In poor condition

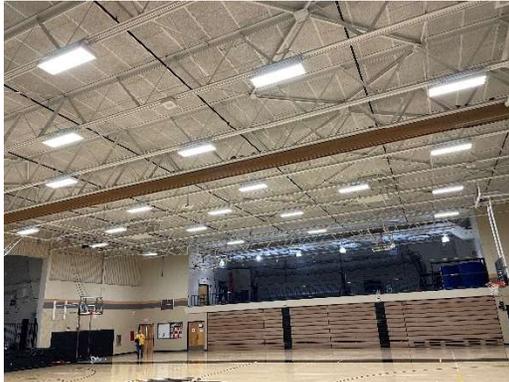
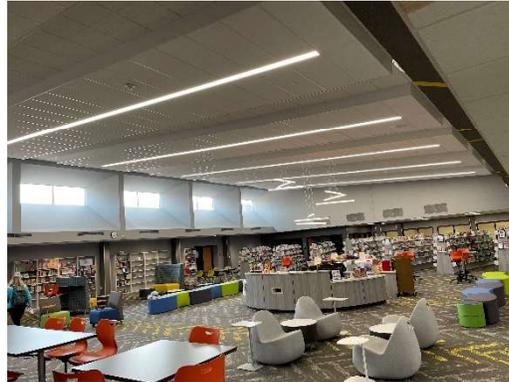
- ✓ Most of the building lighting is LED
- ✓ Exit lighting throughout the building appears to be LED style lighting

- ✓ Replace Fluorescent lighting in Fieldhouse with LED
- ✓ Replace Fluorescent lighting in MS Gym with LED
- ✓ Replace Fluorescent lighting in East Wing classrooms and corridors with LED

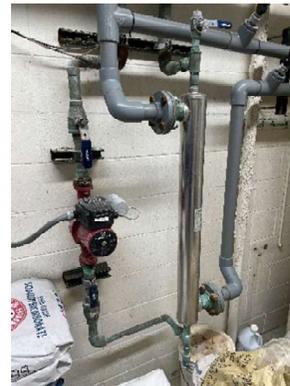
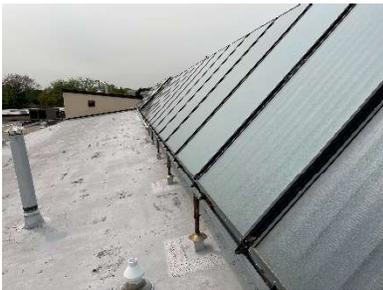
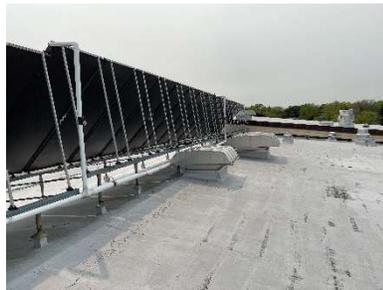
- Existing solar pool heating system is not in use.

- ✓ Recommission the solar pool heating system to provide supplemental heating water to the pool.

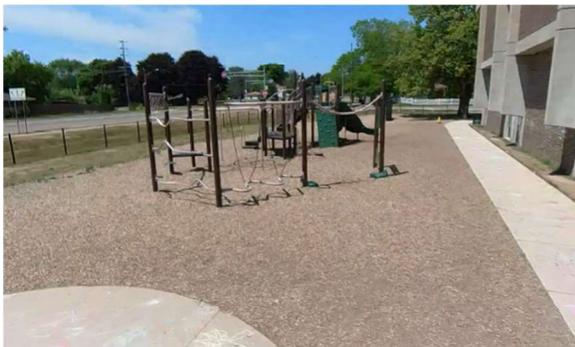
*EC Playground - should have ADA compliant paths and equipment*

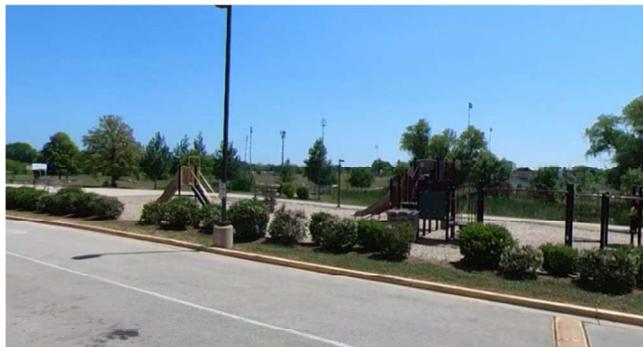
*Playground - Should have ADA compliant Equipment & Paths - Kids must cross traffic lane to access playground*

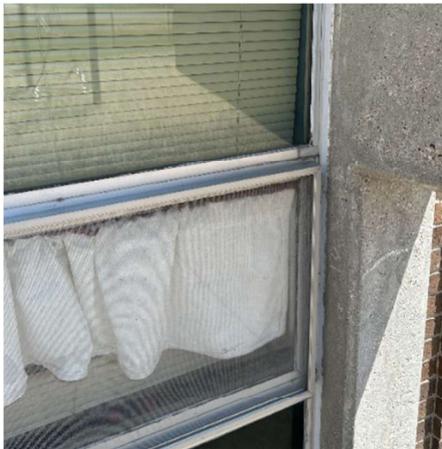
*Original Single Pane Windows and Non-Thermally Broken Window Systems*

- Repair brick at crack locations.
- Replace old, cracked, loose, or missing control joint sealants.
- Replace older windows with new thermally broken windows.
- Perform minor repairs in the roof membrane fields and details.

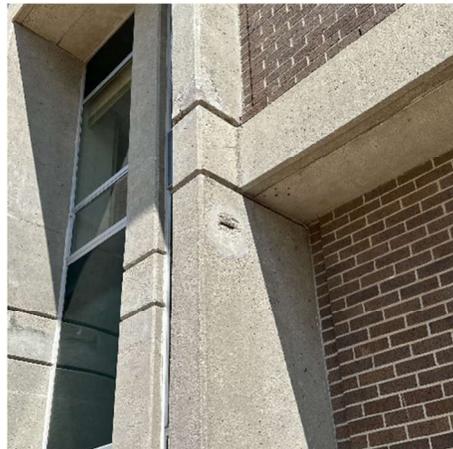
*Concrete Spalling Off Columns*

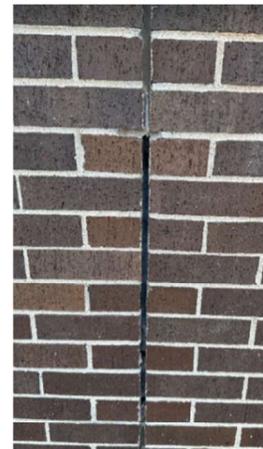
*Missing Control Joint Sealant*

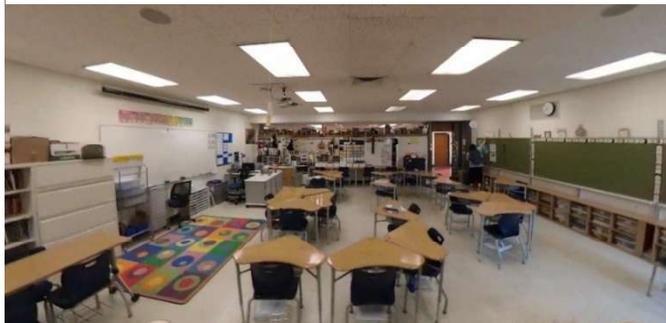
*Classroom W/ Older Finishes*

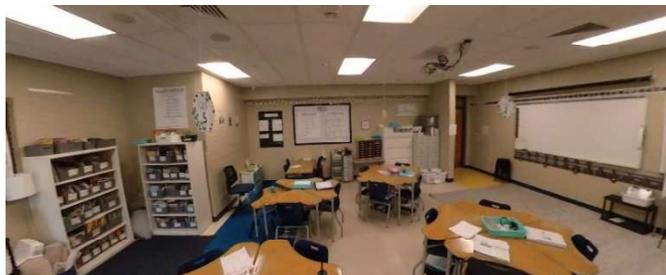
*Classroom w/ Older Finishes*

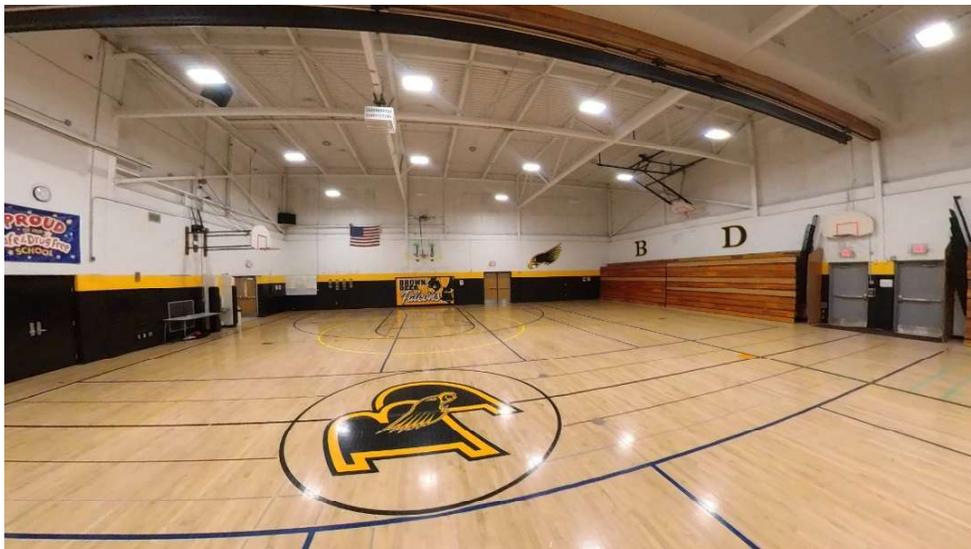
- The existing gymnasium is a single-station gym with two short cross-courts.
- The bleachers are steel frames with wooden seats and do not currently have stair aisles, handrails, or ADA cutouts.
- The original folding partition divider wall has been replaced with a motorized drop curtain.
- The floor appears to be in good condition.
- The perimeter of the upper portion of the gym has tectum acoustic panels that have seen a fair amount of wear. Also, the exposed cross-bracing provides an area for ball entrapment.
- The gym has a bouldering wall that appears to be in good condition.

*ES Gymnasium Fair Condition Overall*

- Consider replacing bleachers to provide ADA-compliant seating.

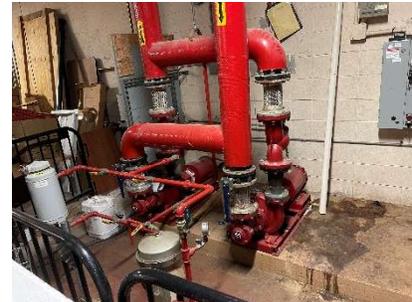
- ✓ The building has a single heating plant
  - (1) Thermal Solutions boiler
    - Installed in 2019 / 4 years old
    - Good condition
    - Average service life is 30 years
  - (1) Fulton Reliance boiler
    - Installed in 2009 / 14 years old
    - Has been decommissioned due to failure
    - Average service life is 30 years
  - Boiler circulation pumps are provided as part of each boiler
    - Pumps are in fair condition
    - Pumps are constant volume
  - Main heating water pumps are constant-speed pumps
    - (2) pumps manufactured by Bell & Gossett
    - Pumps are in average condition

- ✓ Replace Fulton boiler with new Thermal Solutions boiler to bring heating plant to full capacity.

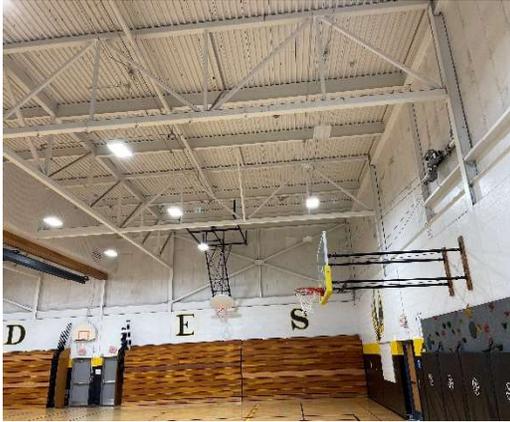
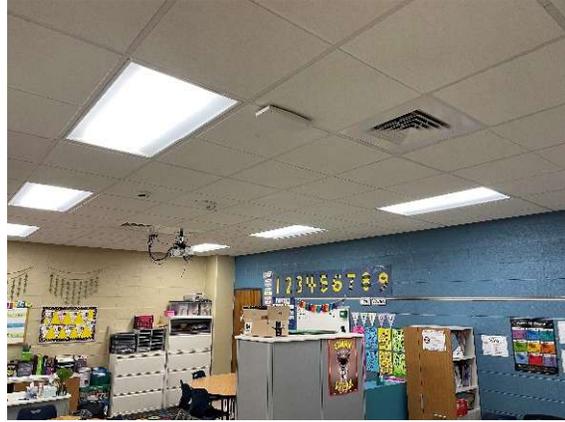
- ✓ Part of the building lighting is LED lighting.
- ✓ Exit lighting throughout the building appears to be mostly LED.

- ✓ Replace remaining fluorescent lighting with LED.

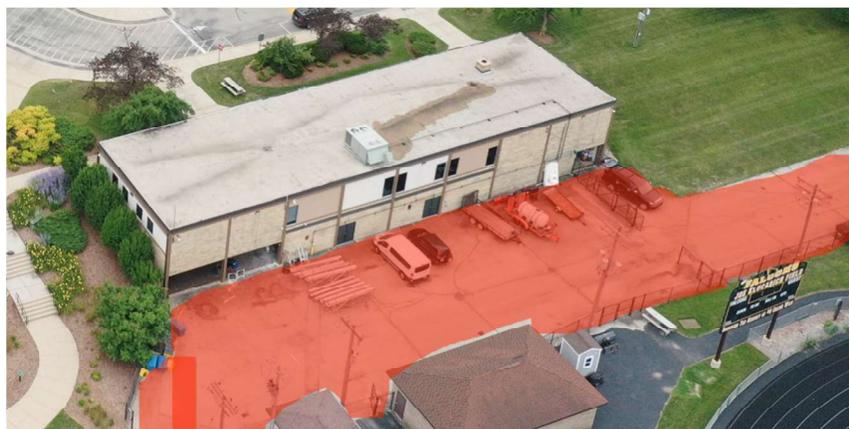
*Poor Asphalt & Drainage*

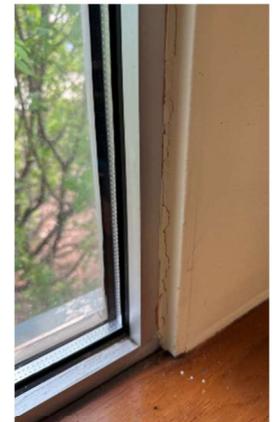
*Window Replacement*

- Consider replacing the exterior stair in conjunction with the wall repair below.
- Consider replacing the window system with new thermally broken windows.
- Consider renovating the restrooms and removing the exterior access.

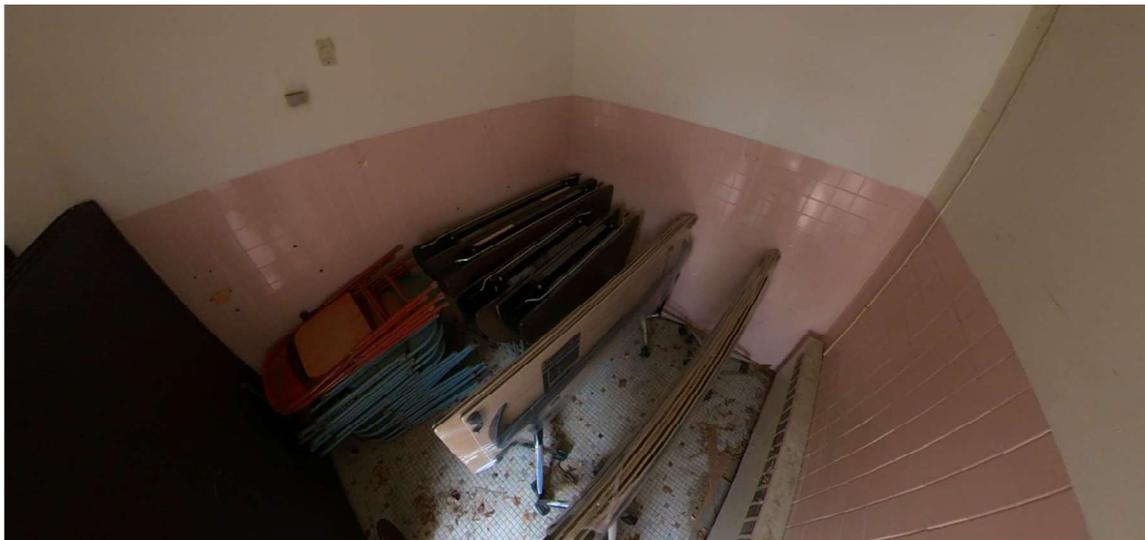
- Existing restrooms are not ADA-compliant.
- Exterior restrooms are not used and are in need of repair.

*Exterior Restroom Underutilized*

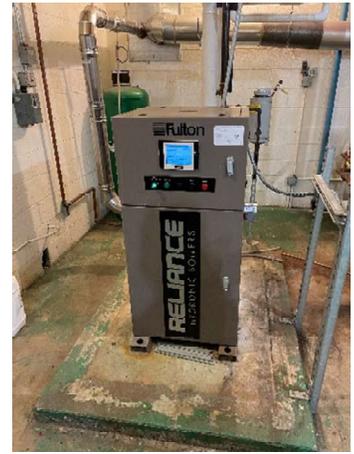
- ✓ The building has a single heating plant
  - One (1) boiler
    - Installed in 2009
    - In poor condition
    - The boiler has begun experiencing various failures with increasing frequency
    - Average service life is 30 years
  - Main heating water pump is constant speed
    - Pumps are in poor condition

- ✓ Replace the existing boiler plant with a new high-efficiency condensing boiler and variable-speed pumping.

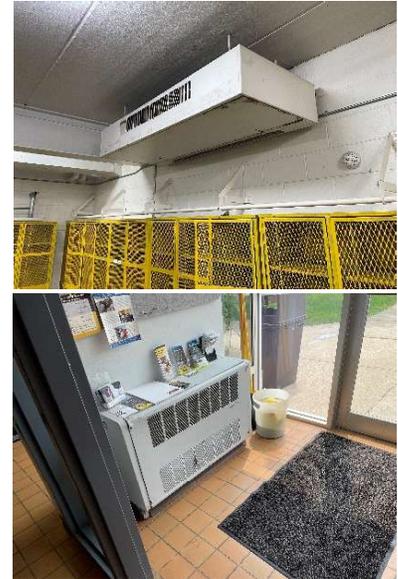
- ✓ Lower-Level Locker Rooms are served by Unit Ventilators
  - Units are original to the building
  - Average service life is 20 years
  - In poor condition
  - Provides Heating (hot water) and Ventilation
  - Serves individual spaces
- ✓ Various Unoccupied spaces are served by Cabinet Unit Heaters and Unit Heaters
  - Units are original to the building
  - Average service life is 20 years
  - In poor condition
  - Provides Heating (hot water) and Ventilation
  - Serves individual spaces

- ✓ Replace existing Unit Ventilators with new units to provide improved ventilation. Units should be sized for low-temperature water to provide heating efficiency from a new boiler plant.
- ✓ Replace existing terminal heat with new units. Units should be sized for low-temperature water to provide heating efficiency from a new boiler plant.
- ✓ Recommend adding zone control to the existing rooftop system. This would be accomplished by adding variable air volume boxes with terminal reheat and distribution ductwork.

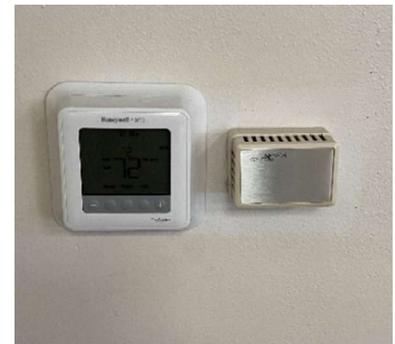
- ✓ Existing controls are limited DDC electronic with some pneumatic
  - Controls are in poor condition

Provide a new Direct Digital Control (DDC) System when major equipment is replaced.

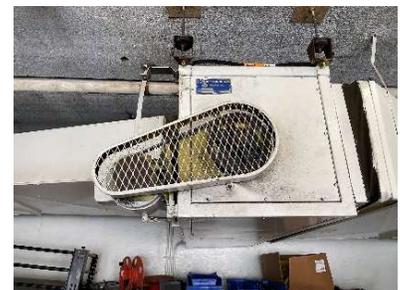
- ✓ Exhaust fans appeared original to the building and are in poor condition.

- ✓ Recommend replacing exhaust fans with associated major HVAC equipment replacements.

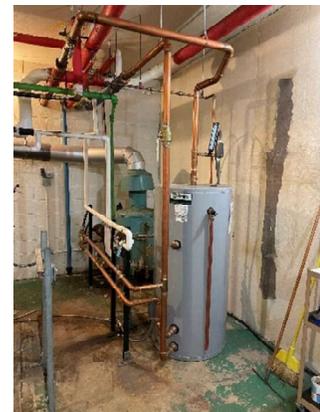
- ✓ The domestic water heater is original to the building.
  - System is currently oversized for existing facility use (Lockers not currently in use)
  - Appears original to the building
  - In poor condition
  - Standard efficiency
  - Average service life of 15 years

- ✓ Replace the water heater with a new high-efficiency condensing hot water heater.

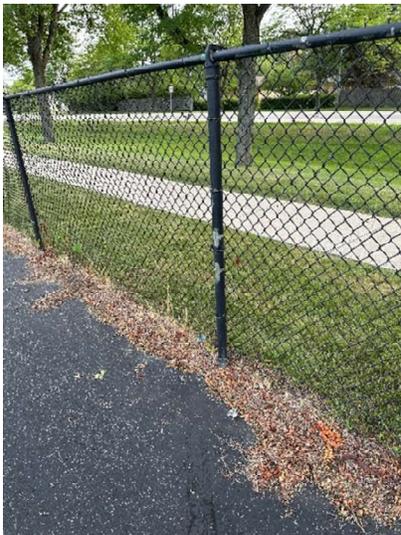
- Fencing around the stadium complex appears to be in good physical condition, but the black paint has peeled off of the galvanized posts in several locations.

*Paint Peeling From Perimeter Fencing*

- Consider resurfacing the track.
- We recommend repainting the posts.

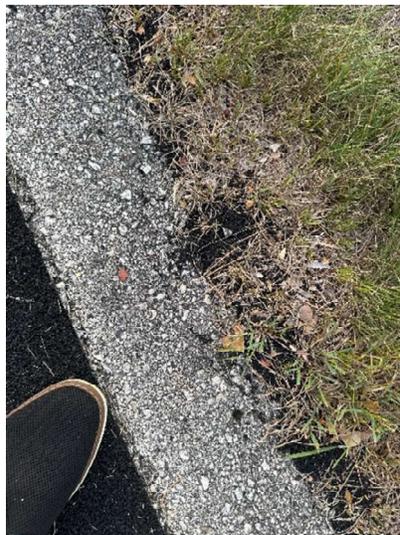
- Field goals and other field apparatus appear to be in good working order
- The track base does not show signs of cracking; however, the top surface appears to be at the end of its useful life and should be considered for replacement/reconditioning. The markings on the track have faded/worn, and there is evidence of rubber granules collected at the perimeter of the track.

*Eroded Track Surface*

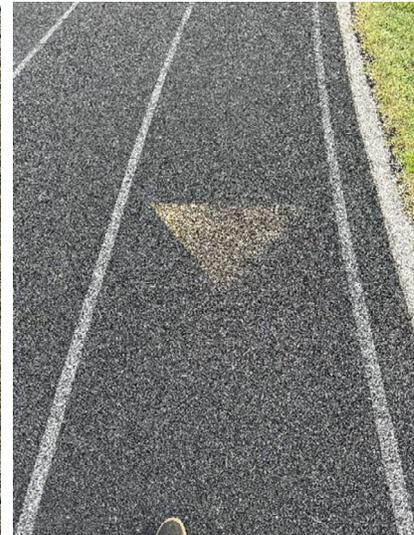
*Faded Track Markings*

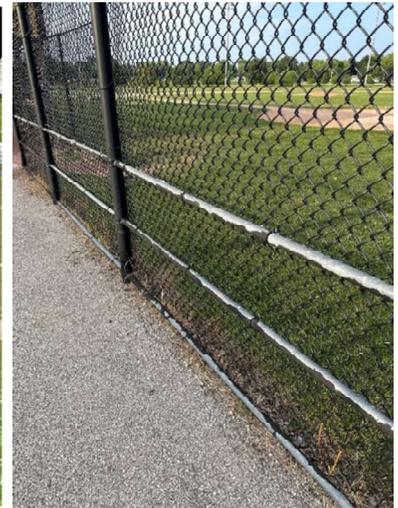
- The existing baseball and softball fields appear to be in fair condition but require minor grading improvements to deal with drainage and variations in the ground surface.
- The Fencing around the baseball field is peeling and should be repainted.
- The softball field is not currently accessible via an ADA-compliant path, nor has ADA-compliant seating. Recommend constructing a concrete walk and pads for the bleacher seating.

*Paint Peeling from Backstop Fence*

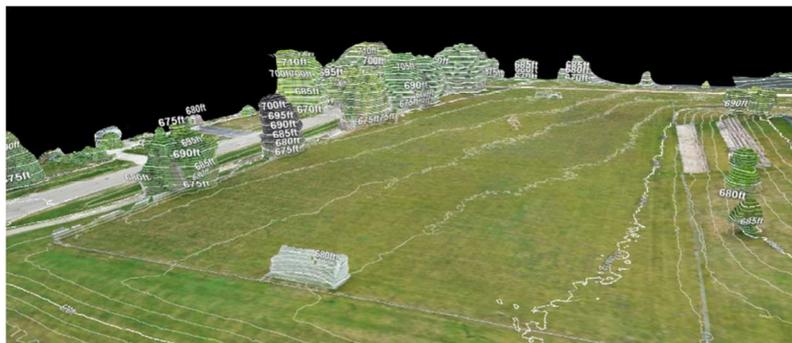
- The varsity soccer field is in good condition, with minor repairs needed for netting and equipment.
- The JV field has a constant cross slope and could be considered for regrading; however, the use and size of this field appear to be limited to Jr. games.
- Neither field has an accessible route nor accessible seating. Consider building a concrete path and pad for bleacher seating.
- The Varsity Soccer Field does not have lighting, which limits its use.
- The Varsity Soccer Field is well-graded and built on the old site of Dean Elementary. However, the grade slopes away from the field rather quickly, just outside of the boundaries of the field, creating a challenging runup for corner kicks and throw-ins.
- Ball containment nets behind the goals need repair or replacement. Also, soccer balls tend to roll down the slope to the west and into the retention basin.

*Cross Slope*

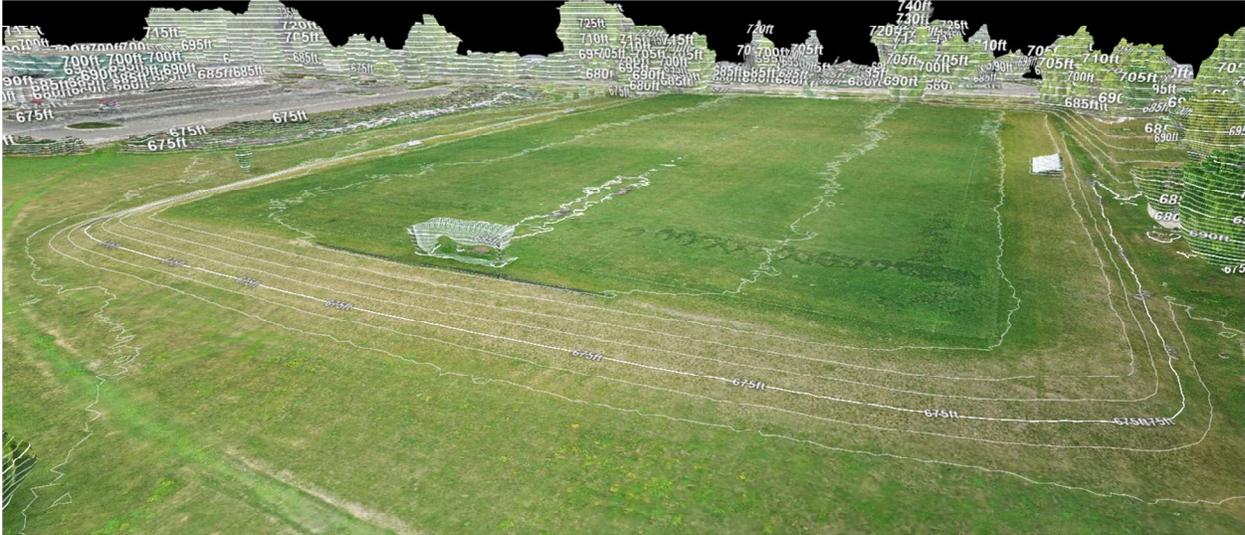
*Varsity Soccer - Slopes off quickly at end lines*

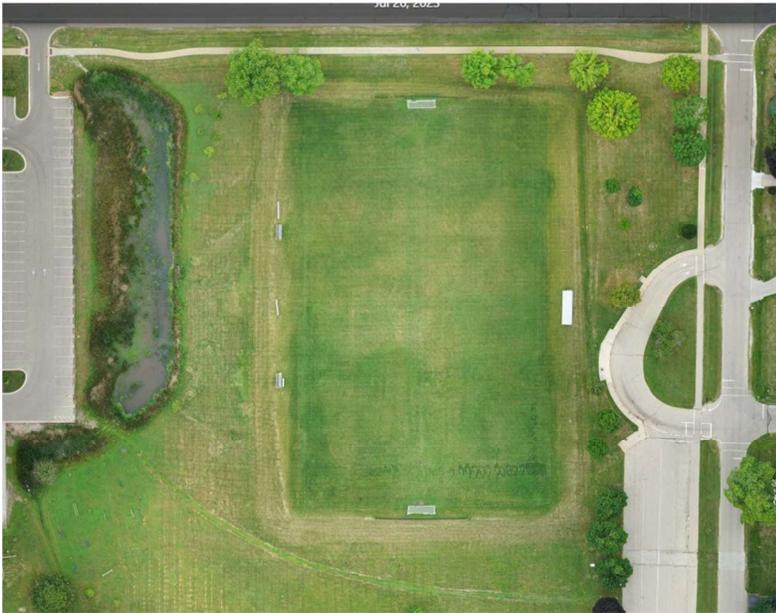
*Varsity Soccer Drone Image – Drainage Area West of Field*
